The Japan Tohoku Tsunami of March, 2011

Part I: Preliminary Observations of Effects on Buildings

By Gary Chock, S.E.

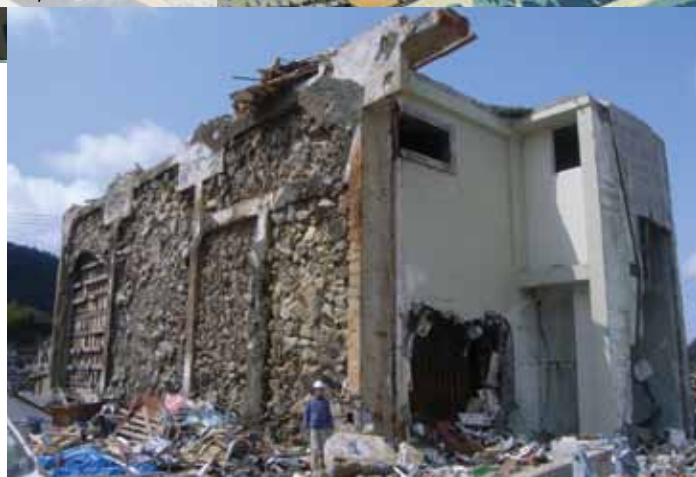
Figure 1: Overturned Cold Storage Building in Onagawa.

One illustration is a two-story reinforced concrete cold storage building (Figure 1), which had the refrigerated storage on the ground floor and the refrigeration equipment on the second floor. Due to this function, the building consisted of a closed concrete shell except for doors and a few windows of its administrative room, and ventilation. The building was lifted by hydrostatic buoyancy off its pile foundation, which did not have tensile capacity, and carried over a low wall before being deposited about 50 feet inland from its original location. This building was approximately 30 feet by 70 feet in plan, and 40 feet tall.

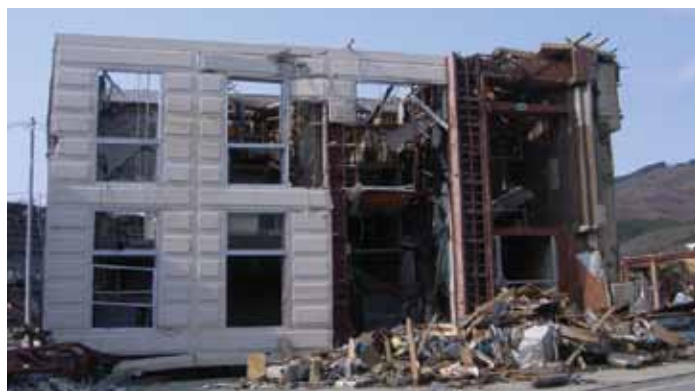
Figure 2: Overturned Steel-Framed Office Building in Onagawa.

Other overturned concrete and steel buildings were sufficiently open to relieve hydrostatic uplift, but were still toppled by hydrodynamic forces of the incoming or returning flow. A four-story structural steel moment-resisting frame (Figure 2) lost many of its lightweight precast concrete cladding panels and had numerous window openings. Nevertheless, the building's spun-cast precast piles were sheared off or extracted from the ground, and the office building was displaced by about 50 feet. Skid gouge marks were found on the pavement leading back to its original location.

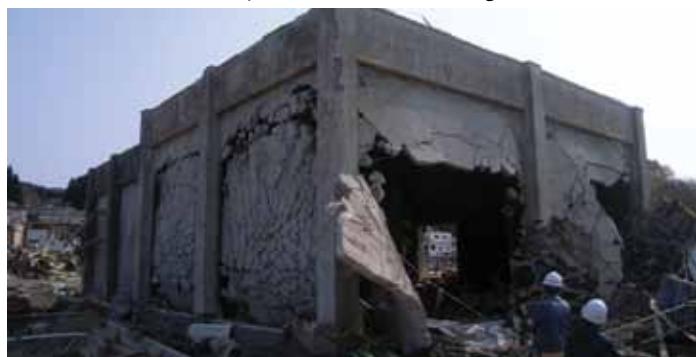
Figure 3: Onogawa Reinforced Concrete Building Frame Structure with Shear Wall Blow-outs.

In many communities, buildings experienced wall failure due to hydrodynamic forces. The simplest cases of this effect were buildings that had three-sided, enclosed spaces that became pressurized by flow stagnation. Flexural yielding led to a catenary membrane condition followed by overall punching shear of the body of the wall. The reinforced concrete building frame system shown in Figure 3 had its shear walls blown outward by the flow returning to the ocean, entering through the door visible on the far side.

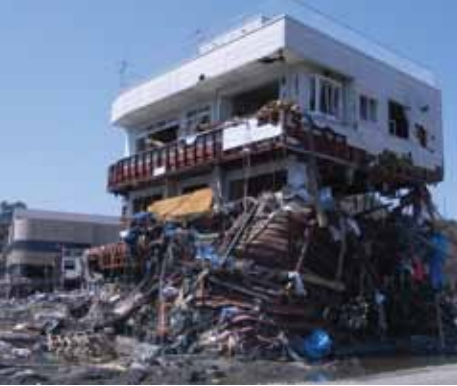
Figure 4: Otsuchi Town Three-Story Steel Moment-Resisting Frame with 15-foot tall Enwrapping Debris Load.

recreates bluff body effective projected areas. The three-story steel moment-resisting frame building shown in Figure 4 with a 15-foot tall debris pile is an illustration. Note the roof decking material bent around the corner. This building frame in Otsuchi Town was essentially undamaged in a 30-foot inundation height, due to a robust structural design that in effect did not rely on breakaway cladding. Note evidence of tsunami inundation at the height of damaged cladding and top floor windows and balcony soffit.

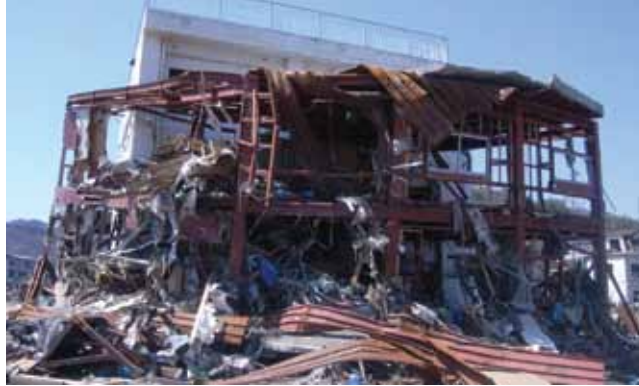
Figure 5: Otsuchi Town Collapsed Three-Story Steel Moment Resisting Frame with Debris Load.

The three-story steel-moment-resisting frame shown in Figure 5 had significant debris wrapping. The frame collapsed due to yielding of the top and bottom of all first story columns, then was transported by the incoming flow and crushed and compacted sideways against the three-story reinforced concrete building in the background. Thus, the steel building frame, itself laden by debris, became a large-scale debris load on the adjacent structure.

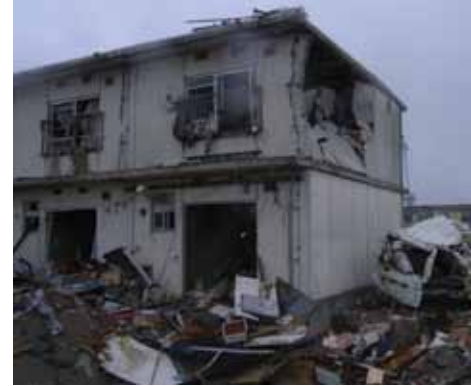
Figure 6: Ian Robertson of the ASCE Tsunami Reconnaissance Team Examines the Results of a Tsunami Bore-Projectile Car Impact on a Structural Precast Bearing Wall Apartment Building in Yuriage, Natori.

In addition to building components and even whole buildings, tsunami debris flows include discrete masses such as floating vehicles (Figure 6), logs and trees, rolling boulders, large and small concrete fragments, boats and ships, shipping containers, and fuel and oil storage containers. These projectiles can impact building exterior walls and structural columns. Vertical load-carrying structural elements without enhanced local protection or redundant alternative load paths are more susceptible to such impacts and possible partial collapses.
