Restoration of a Covered Bridge over Troubled Waters... And Underneath Calm Ones

The Metamora Aqueduct carries the Whitewater Canal across Duck Creek (Figure 1). The canal was built in 1839 as part of Indiana’s massive internal improvements program. State bonds were used to fund transportation improvements based on the proposition that they would increase property values, resulting in greater tax revenue, which, in turn, would pay off the bonds. When this did not happen, the State defaulted on the bonds. The resulting scandal caused a prohibition against deficit spending to be added to the state constitution, the continuing effect of which can still be seen every time the legislature wheedles and whittles to pass a balanced state budget.

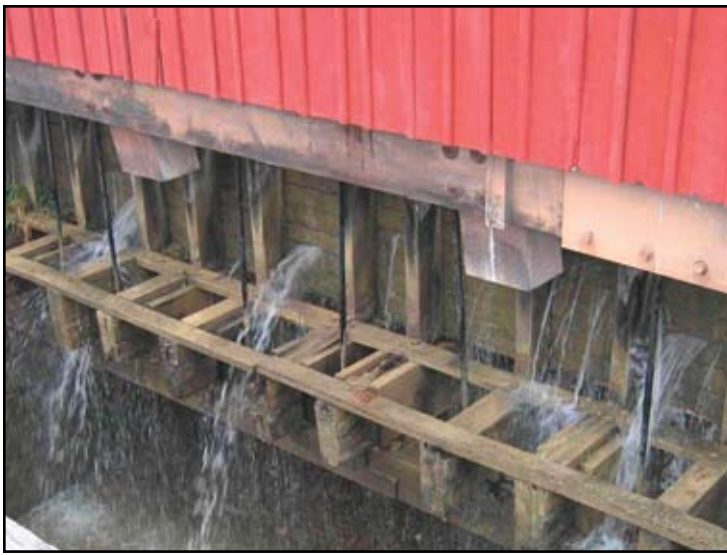
In 2004, the State of Indiana approached the author requesting that a new flume be designed for the aqueduct. The flume, which is the part of the structure that actually holds the water, had been leaking for years (Figure 3), soaking the floor beams underneath and causing them to decay and break. In this bridge, the flume is made of wood planks suspended by steel rods from the trusses, which are entirely above water level. This arrangement is doubly clever because it protects the all-important trusses from splashes and leaks, and allows the flume to be easily raised or lowered to maintain the exact desired bed elevation

Figure 3: Leaks in the flume caused decay in its supporting structure.

White oak was chosen for the new material for the flume because of its superior performance in wet environments. In the American Midwest, the two most common varieties of oak are red oak and white oak. An important difference is that the longitudinal sap-carrying vessels in red oak are clear, while those in white oak eventually develop growths that plug them. Thus, white oak is less porous and lasts longer in wet environments. The new flume liner boards have tongue and groove edges, and a thin line of sealant was applied to the tip of each tongue just before the adjacent board was placed against it. In contact with water, the boards swell slightly, completing the seal.

Since the 6-inch by 16-inch by 24-foot long floorbeams supporting the flume could be subjected to wetting, they were also cut from white oak. IDNR wished to use traditional technology for the repairs, and avoid lumber treated with preservatives.

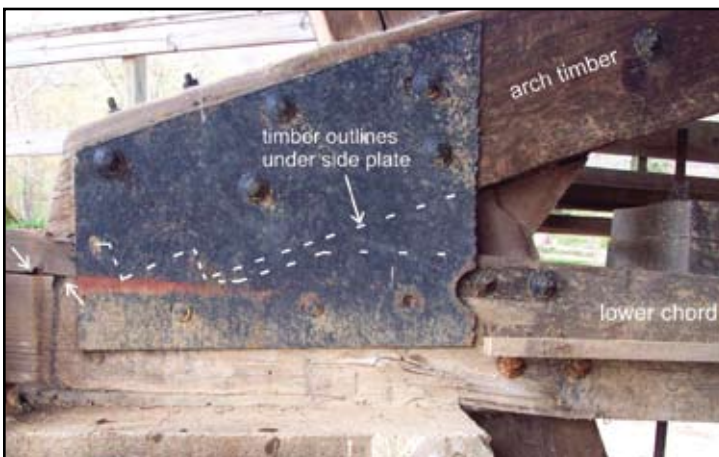
The original truss design contained an odd and inefficient detail. Instead of pressing against the stone abutments, the heavy arch rings stopped 12 inches short of the stone, and notched into the lower chord timbers (Figure 4). Thus, the bridge was a tied arch rather than a true Burr Arch or Wernwag Truss. Scale drawings from the 1930s show that this was the original construction. The logic of stopping the arches 12 inches short of good bearing was perplexing.

The arch thrust, pressing on the 2-inch deep notches, had sheared off the ends of the lower chord timbers. Steel side plates and clamping bolts had been added in the past to reinforce those connections, but the shear failure, arch ring spreading, and midspan sag remained. The 79-foot long lower chord timbers were spliced at their third-points using scarf joints with side plates, and those splices were also examined. Steel side plates on the splices had been painted for rust protection, and some paint fell on the adjacent timbers. A tell-tale gap in the overspray paint (Figure 5) testified clearly that the splices were failing also.

Figure 4: Typical bearing seat. Thrust from arch sheared top of lower chord, splitting a bolt hole (arrows). Lower chord crushed and curved as it passed the face of abutment.

Repairs were also needed at the ends of the arch rings over the bearing seats. As the truss was jacked, the sheared ends of the lower chords were pushed back to their original positions and fastened in place. Then, wood blocks were added between the end of each lower chord timber and the abutment to partially transmit the thrust of the arch ribs into the abutment, reducing

the tension force in the lower chord. This changed the structural action from a tied-arch to more nearly that of a Wernwag truss. Such a significant change in structural behavior is rarely acceptable. But in this case, the benefit was so great and the visual impact so slight that it was viewed as a reasonable compromise between the competing goals of achieving a durable repair and maintaining the intent of the original designer.

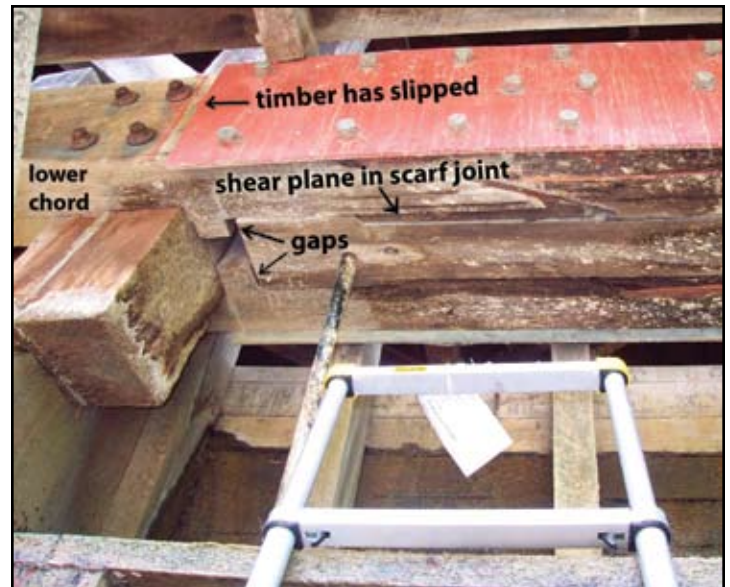
The arch-truss was analyzed using a 2-dimensional finite element model. The analysis indicated that the timbers were adequate to carry the dead load and live load with satisfactory margins of safety. But when member forces were routed through the connection details (done by hand analysis), the lower chord splices and arch-end connections appeared to be overstressed. This was expected, as the actual failures had already been noticed.

Figure 5: A failing splice in lower chord timbers. Unpainted strip at left shows timber has slipped.

In this case, the solution called for the trusses to be shored and jacked to restore a positive camber (*Figure 6*). Then, the lower chord splices would be rebuilt, and two particularly splintered lower chord timbers would then be replaced in kind. The removed timbers, each 10-inch x 15-inch x 27-foot long, would be used as patterns. The new timbers were Douglas fir, which (unlike poplar) could be found well seasoned in the needed size. The new steel plates would be longer, but narrower, than the old (1948) plates, and would have keyways to help transfer the load (*Figure 7*). Epoxy adhesive would be used sparingly to assure equal bearing in all keyways.

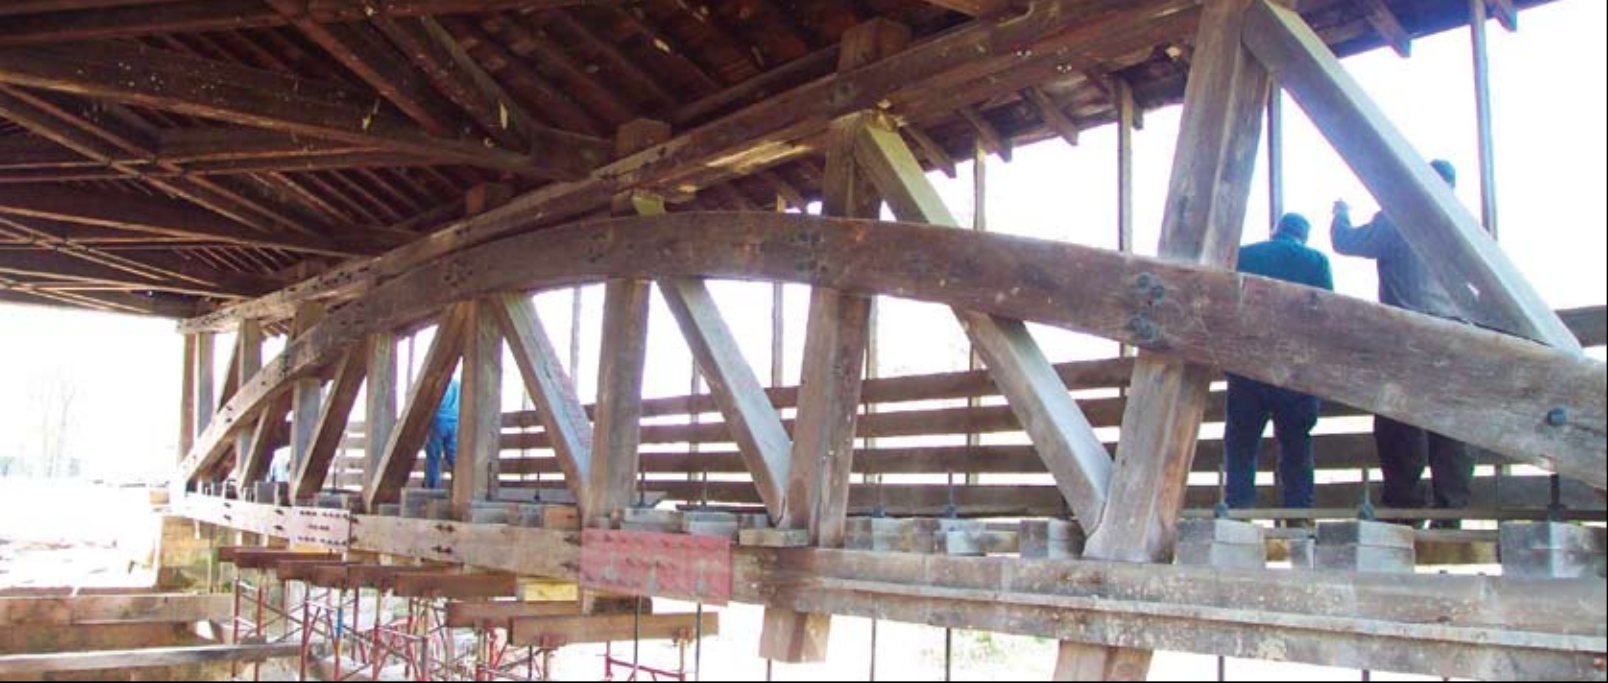
Figure 6: IDNR engineers inspect the shored, but not yet jacked, trusses. They are standing on the walkway for the tow horses.

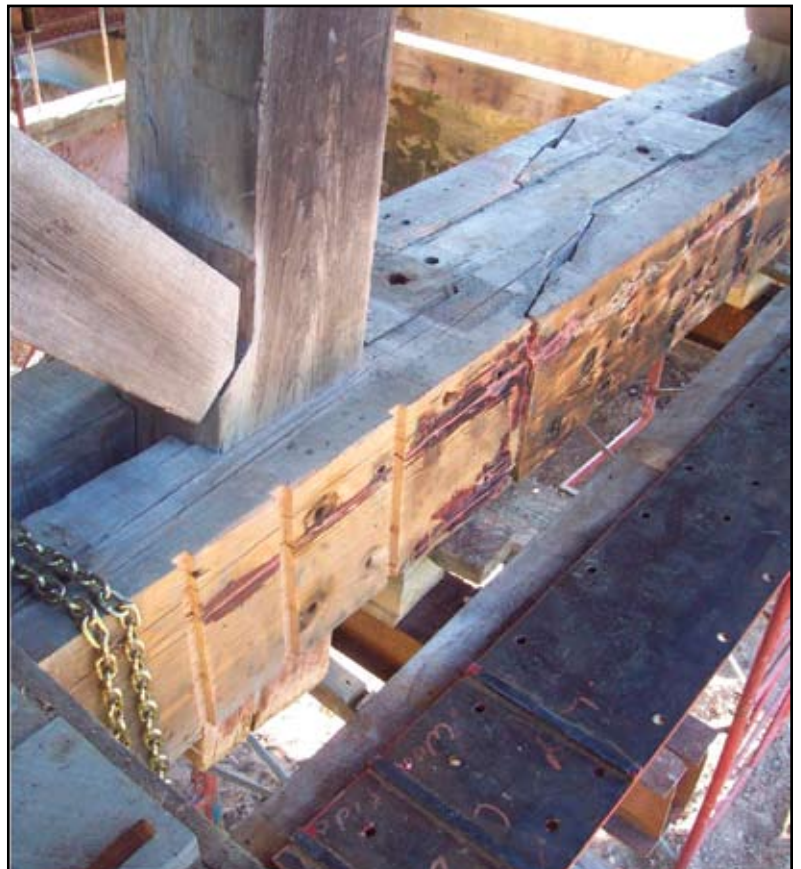
Figure 7: Scarf splice in lower chord. Keyways have just been cut in wood to match those on new side plate. Timbers that loosened when sag was jacked out were resealed and shimmed.

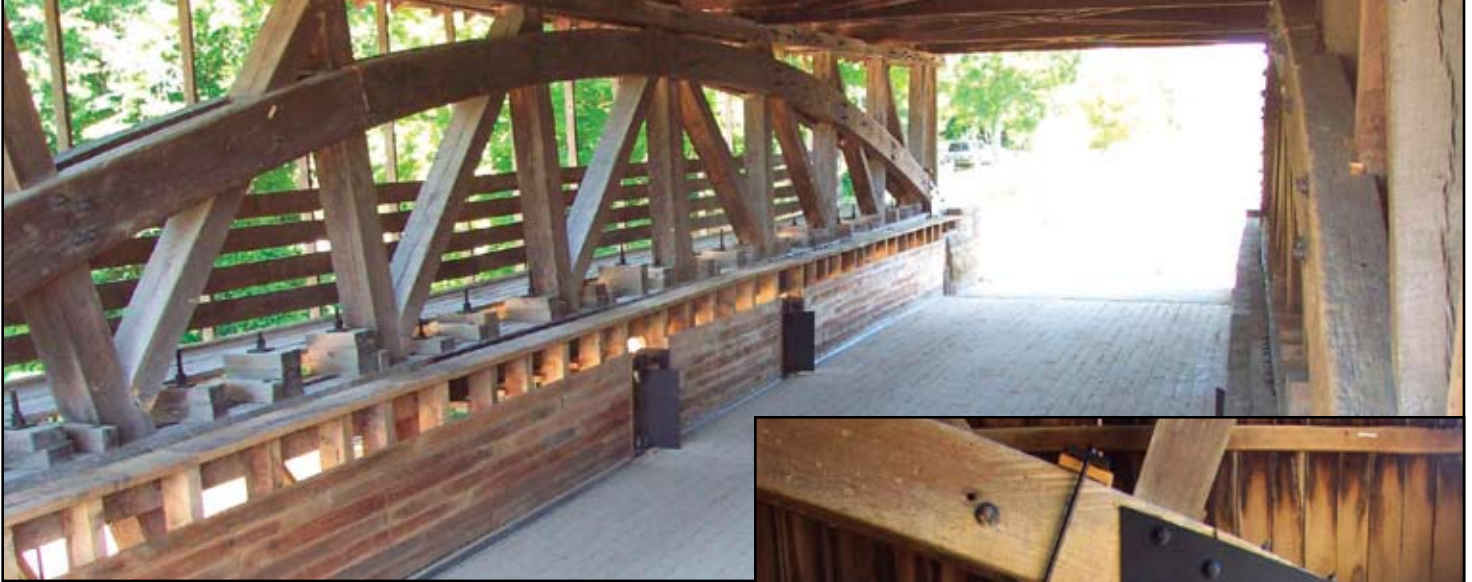
Figure 9: Completed project just before work-dam was removed. Butterfly gates in flume walls help regulate the water level.

The bridge is now repaired and ready for additional decades of service. The contractor's craftsmanship was excellent, and the chronic problems of weak splices, sagging trusses, and a leaky flume are now fixed. The project's \$207,000 total cost was a modest price to preserve the last historic timber aqueduct in America (Figure 9).

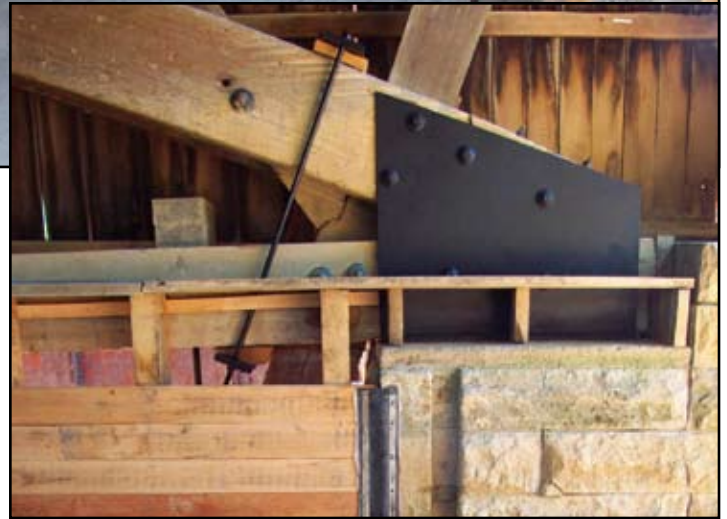
The sustained weight of the canal water had started to crush the lower chords at the bearing seats. To counteract this, the existing steel side plates were replaced with ones that extended down to the

Figure 8: Bearing seat area, new flume, and expansion joint seal after repairs were completed.

Sealing the connection between the wooden flume and the stone abutments had been problematic for decades. Carefully detailed caulked joints had been tried, but they quickly failed. Neoprene compression seals were installed, but partially failed and left wide gaps. For this project a new seal was designed, consisting of a 7-inch wide strip of 60 mil EDPM roofing, clamped down along both edges using 1/8-inch x 1-inch stainless steel bars. Although very simple, this design has sealed the gap with no leaks whatsoever.

abutment. If the wood continues to compress, the side plates will help carry the vertical load to the abutments, reducing the stress in the wood (Figure 8). A tension tie was added next to each bearing seat to help support the lower chord a short distance from the abutment. Photos from 1935 show similar tension ties in place.
