STRUCTURAL REHABILITATION

Timber Truss Bolted Connection Repair and Full-Scale Load Testing

By Zeno Martin, P.E., S.E.
and F. Dirk Heidbrink, P.E.

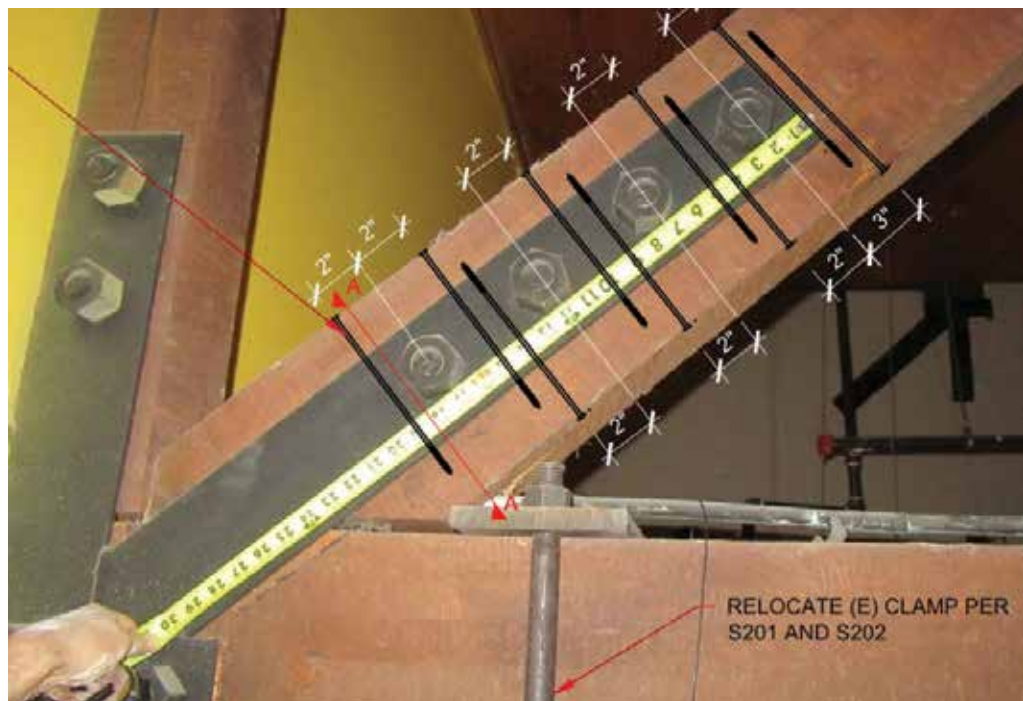
Excerpt from design drawings for added HeadLOK screws placed around existing bolts to clamp wood and resist splitting.

- 1) Where design demands exceeded allowable bolted connection capacities from 1% to 30%, then supplemental HeadLOK timber screws by FastenMaster were added around the bolted connection to resist potential tension perpendicular-to-wood-grain splitting induced by the

large diameter bolts. The HeadLOK was chosen for its small diameter shaft (0.19-inch), large diameter head (0.625-inch), and short thread length (2-inch). The small diameter shaft does not promote splitting and the large head separated from its threads by several inches serves

to clamp the glued wood laminations together. The capacity of wood to resist tension perpendicular to grain is so low that there are no allowable design values. Assuming allowable tension perpendicular grain stress is equal to allowable radial tension stress to represent capacity, the analysis shows the supplemental HeadLOK more than doubled or tripled, depending on location, the ability to resist tension perpendicular-to-grain splitting in the plane of the bolts.

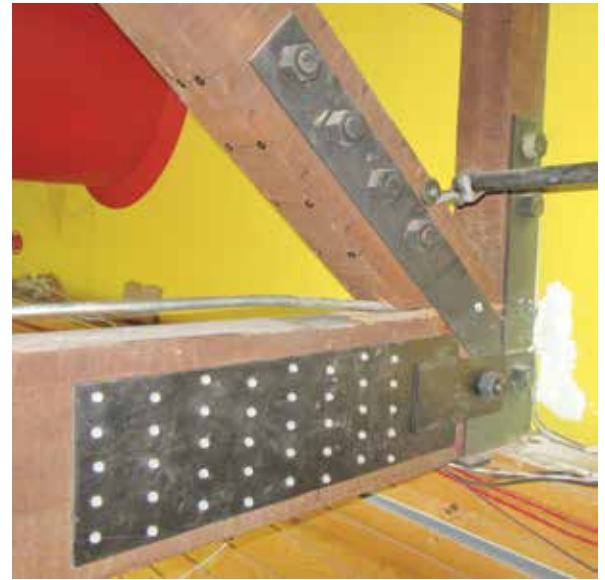
New heel plate connection at the bottom chord and supplemental HeadLOKs installed on the diagonal bottom surface.

- 2) Where design demands exceeded allowable bolted connection capacities by more than 50% (there were no results between 30% and 50%), steel plates were added to bypass the original bolted connection. This occurred at all truss heel connections and all first truss verticals inward of the heel. This new steel plate was bolted to the existing steel gusset plate using AISC 360-10 *Specification for Structural Steel Buildings* design provisions and screwed to the existing wood using Simpson Strong-Tie SDS screws.

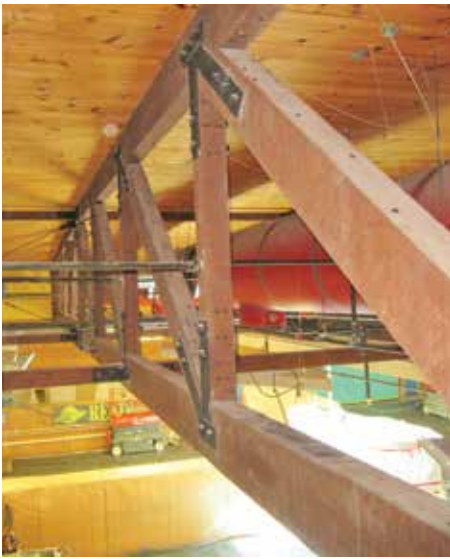
Repaired truss.

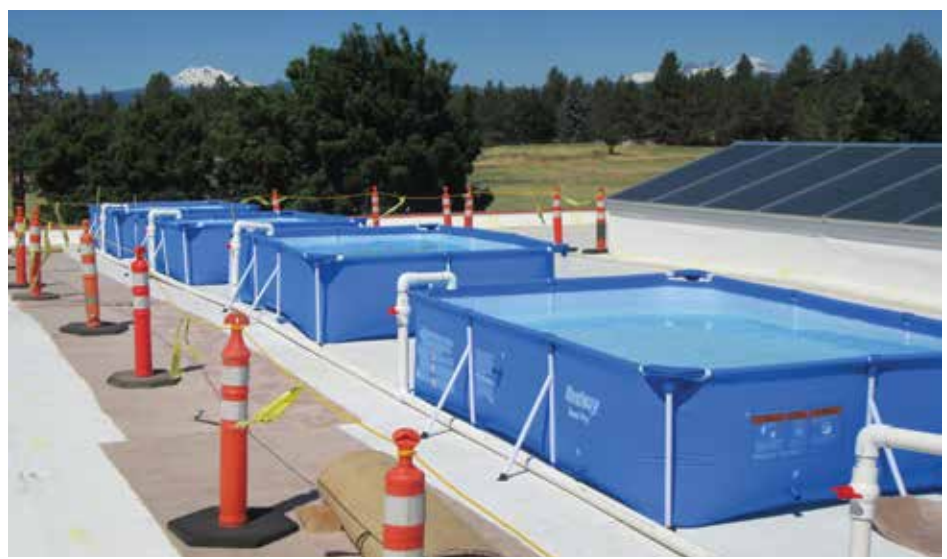
Pools filled with water on the roof during load test of the repaired truss.

The repaired truss passed the load test by meeting both the maximum deflection criteria and the residual deflection criteria and had no distress or failure during the test.
