Up FROM THE Ashes

Rebuilding the Sperry Chalet: Part I

By Ian Glaser, P.E., Jeffrey Schalk, P.E., S.E., and Laine McLaughlin, AIA, LEED AP

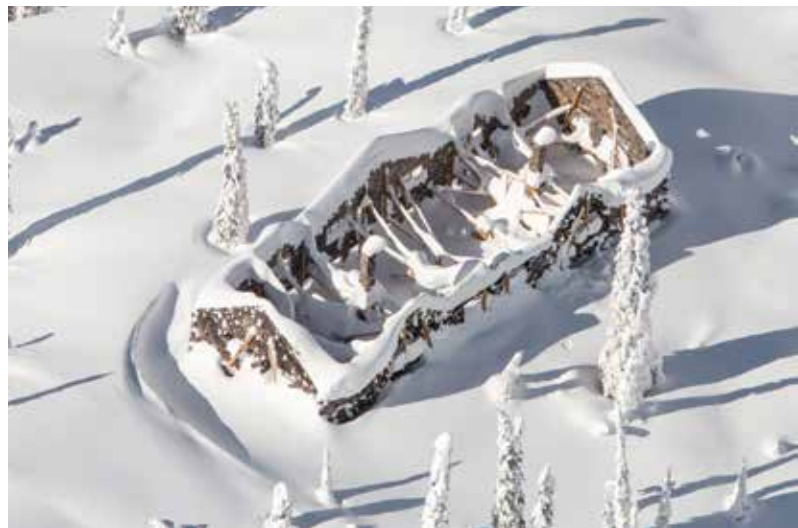
In October, National Park Service (NPS) crews raced to temporarily stabilize the free-standing walls with interior timber bracing before the snows began. The character-defining exterior masonry walls were at risk of collapse from snowdrifts and wind gusts over the upcoming winter season (Figure 1). This emergency stabilization effort was spearheaded by the NPS and the Glacier National Park Conservancy, the park's non-profit funding partner.

Figure 1. The chalet survives the first winter after the fire, thanks to emergency bracing. Courtesy of GravityShots.com.

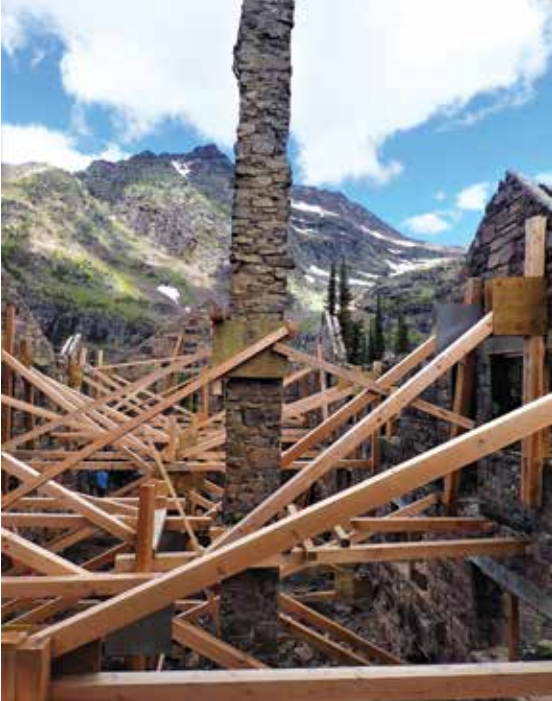
Figure 2. Designers assess the structure in July 2018 amongst the forest of braces.

Two days after the general contractor arrived on site, the design team trekked the 6.7-mile trail to reach the structure perched on the cliffside 3,300 feet above the trailhead at Lake MacDonald. Provisions and hand tools were carried by mule-train, and testing equipment was delivered by helicopter. The purpose of the visit was to validate the construction drawings and begin assessing the fire-damaged stone masonry (Figure 2). While the contractor mobilized and the design team investigated, they collaborated.

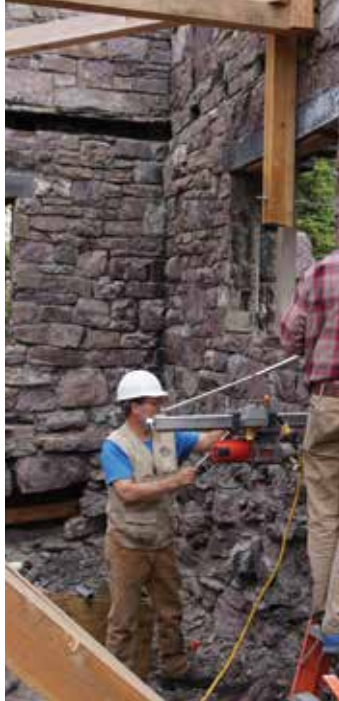
Figure 3. Engineers core-drill the masonry wall.

Bedrock in the crawlspace was cored for laboratory analysis that ultimately confirmed that the geotechnical criteria assumed for the design were appropriate. Surface penetrating radar was implemented to profile the historic masonry walls' layout, and scans were substantiated in strategic locations with video-scoped cores (Figure 3). Several anchors were installed into the masonry walls on the first reconnaissance day. They were load-tested at the end of the trip to verify anchor shear and tension capacities used for the seismic calculations.

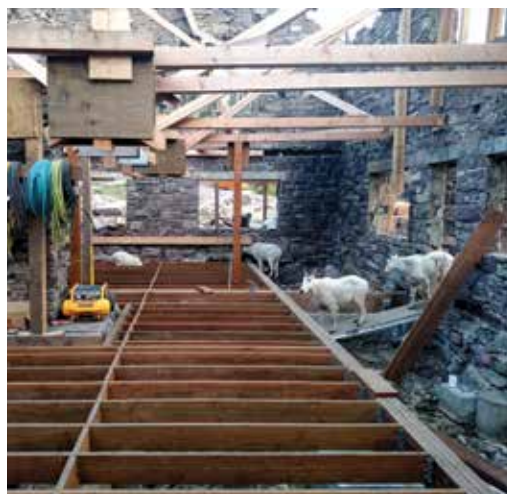
Figure 4. The first floor is framed as interior bracing is progressively removed.

repairing the masonry walls in the next summer. The drawings specified a new exterior raker bracing scheme that supplemented the interior timber bracing. The design stipulated progressive removal of the interior bracing as the floor levels were installed from the bottom up. Temporary stud sister walls, located just inboard of the exterior masonry walls, were designed to support the new structure's weight

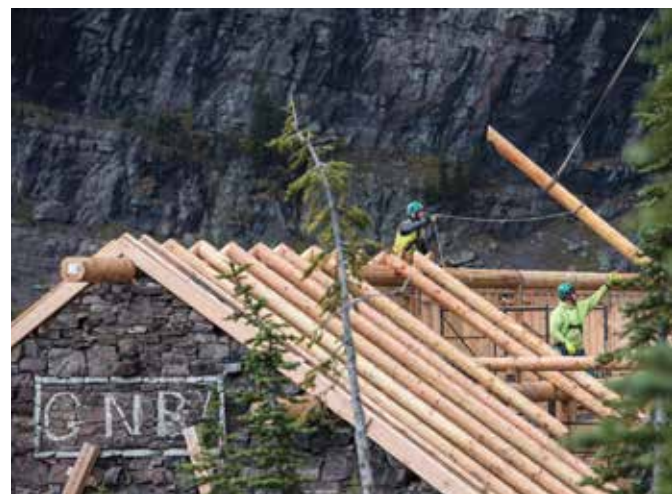
With two alternating crews working seven days a week, the Chalet was enclosed (Figure 5) and the damaged masonry walls re-supported laterally at the end of the first construction phase. The crew demobilized in October as the cold and snow prevented further work. In the summer of 2019, the crews completed the second phase of work, which included repairing the exterior masonry walls and tying them permanently into the structure. The exterior balconies were rebuilt, and the doors, windows, and interior features were installed. Although dampened by COVID-19, the Sperry Chalet welcomed its first guests since the fire in July 2020.

Figure 5. Timber framers set the log rafters via helicopter assist. Courtesy of A Boring Photo.
