# LESSONS LEARNED

## Repairs to Prestressed Strands in Double-Tee Stems

By Luis F. Estenssoro, Ph.D.,  
S.E., P.E.

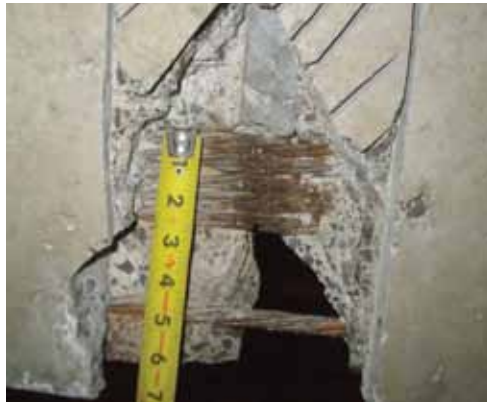
Figure 1.

In the 1971 structure, the main findings at the damaged stem included a crack that developed near midspan of an 86-foot long, 24 LDT double-tee. The crack measured about ¼ inches wide

at the bottom and gradually narrowed to zero near the stem-to-flange intersection. Deflections were not noticeable, most likely because the loads of the damaged stem were being distributed to its sister stem and adjacent double-tees. The damaged stem still had its bottom strand, as described below.

An exploratory opening at the crack was made (Figure 1). It revealed that: 1) the crack developed at the harped point, 2) six strands were used, the top five strands were harped, and the bottom was straight, 3) the top five strands were positioned adjacent to each other vertically, 4) stress corrosion had caused total loss of steel area of the top five strands and the bottom strand developed minor surface corrosion, 5) the vertical steel strut used to maintain the position of the stretched strands at the harped point during manufacturing had been removed and mortar grout placed in the void, 6) no supplemental steel was present in this region of the stem, and 7) signs of cracking and corrosion were not observed beyond the crack.

The prestressed strands were ½-inch diameter strands with a likely 270-ksi ultimate tensile strength. Thus, each strand can carry tension loads in the order of about 30 kips. The concrete stems were nominal 4 inches wide and 22 inches tall.
