STRUCTURAL FORENSICS

Prescription for Repair

The Triage, Life Support and Subsequent Euthanasia of an Existing Precast Parking Garage – Part 2

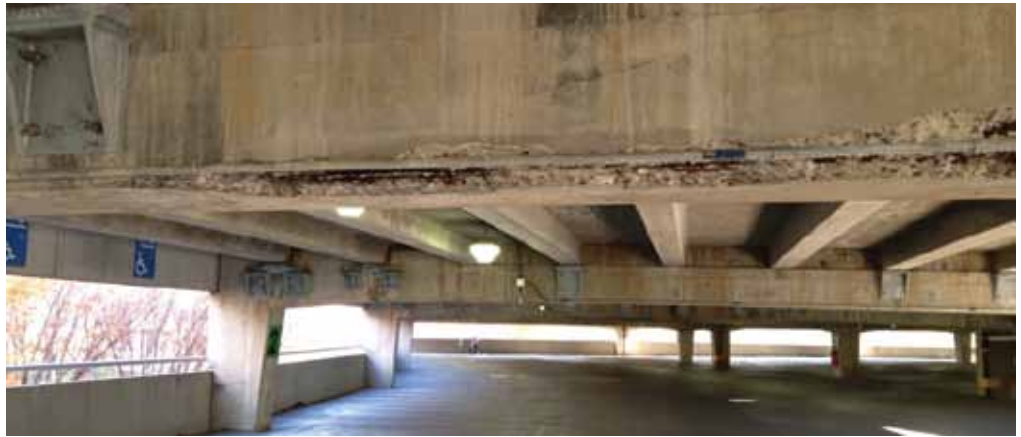
Figure 2 (from Part 1, Sept. 2013): Spalling due to deteriorated strands at precast girder.

The surface spalling and subsurface delamination observed at the girders occurred due to the corrosion of the internal reinforcing (Figures 2 and 3 from Part 1). Corrosion is an electrochemical process that requires an anode, a cathode and an electrolyte. For the existing structure, the moist concrete provided the electrolyte and the embedded reinforcement provided the anode and cathode. Water and oxygen must be present for any corrosion to take place and, in good-quality concrete, high alkalinity slows or stops the corrosion process. However, if the concrete alkalinity is lowered (e.g., due to carbonization) or if corrosive chemicals (e.g., chlorides) are present, the corrosion process will accelerate.

The electrical current that flows between the cathode and anode results in an increase in metallic volume at the anode as iron is oxidized and precipitates as rust. Rust, a byproduct of electrochemical reaction, has a volume three to four times greater than the iron anode from which it originates. As the layer of rust increases due to the ongoing corrosion process, the resulting expansion of the corrosion byproduct causes the surrounding concrete to crack, delaminate and ultimately spall. As the surface of the concrete degrades, the corrosion process accelerates as internal areas of the reinforcing that were previously protected by the concrete cover are exposed to additional moisture and deicing salts (chlorides).

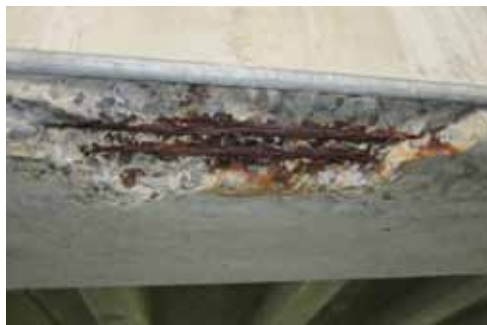
Figure 3 (from Part 1, Sept. 2013): Corroded and failed prestressing strands at precast girder.

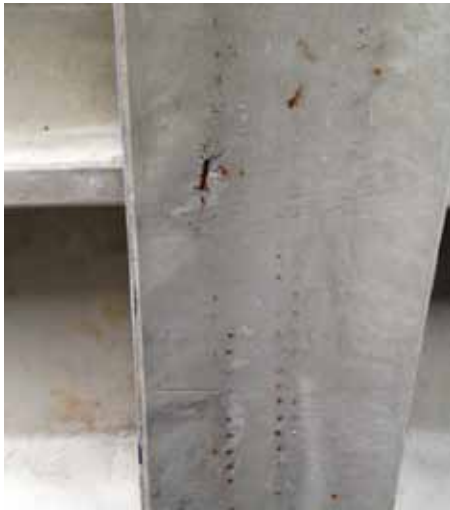
However, field observations (Figure 4 from Part 1) indicated a general lack of spalls and subsurface delaminations in the post-tensioned girders. It was also noted that the cast-in-place, post-tensioned girders were constructed at a slightly later date than the precast girders, so the embedded reinforcing may not have created enough corrosive byproduct at the time of the condition assessment to create spalls as frequently as was observed at the precast prestressed girders.

Figure 4 (from Part 1, Sept. 2013): Rust staining due to internal corrosion of post-tensioned girder reinforcing.
