Electrochemical Treatment

Extending the Life of a Historic Viaduct Structure

By J. Christopher Ball

The 12th Street Trafficway Viaduct

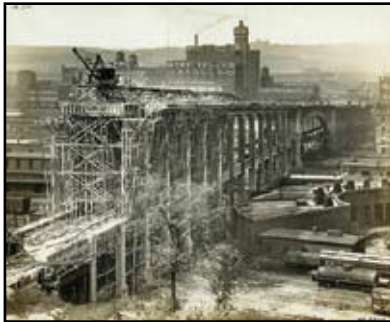
12th Street Viaduct Under Construction, completed in 1915. Courtesy of HNTB Corporation and Architectural & Historical Research Consultants.

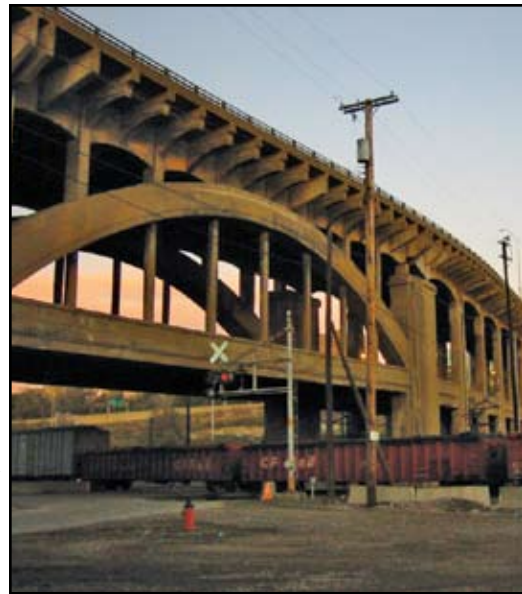
12th Street Viaduct, 2005. Courtesy of Vector Corrosion Technologies.

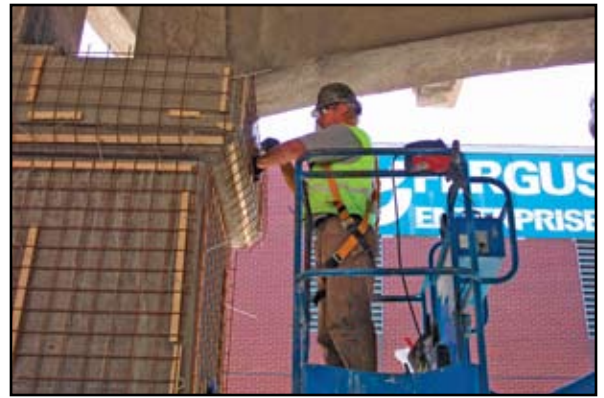
Installation of temporary anode mesh onto concrete surface. Courtesy of Vector Corrosion Technologies.

Wood spacers, approximately 1-inch thick, were anchored to the surface of the concrete using plastic spikes so that there was no chance of electrical shorts. The wood spacers serve two purposes: they act as a spacer to keep the mesh off the surface of the concrete, as well as provide a support to hang the steel mesh anode. The steel welded wire mesh anode was then attached to the wood battens. The mesh was secured around each pier by running plastic cable ties underneath the wood batten spacers and over the mesh.

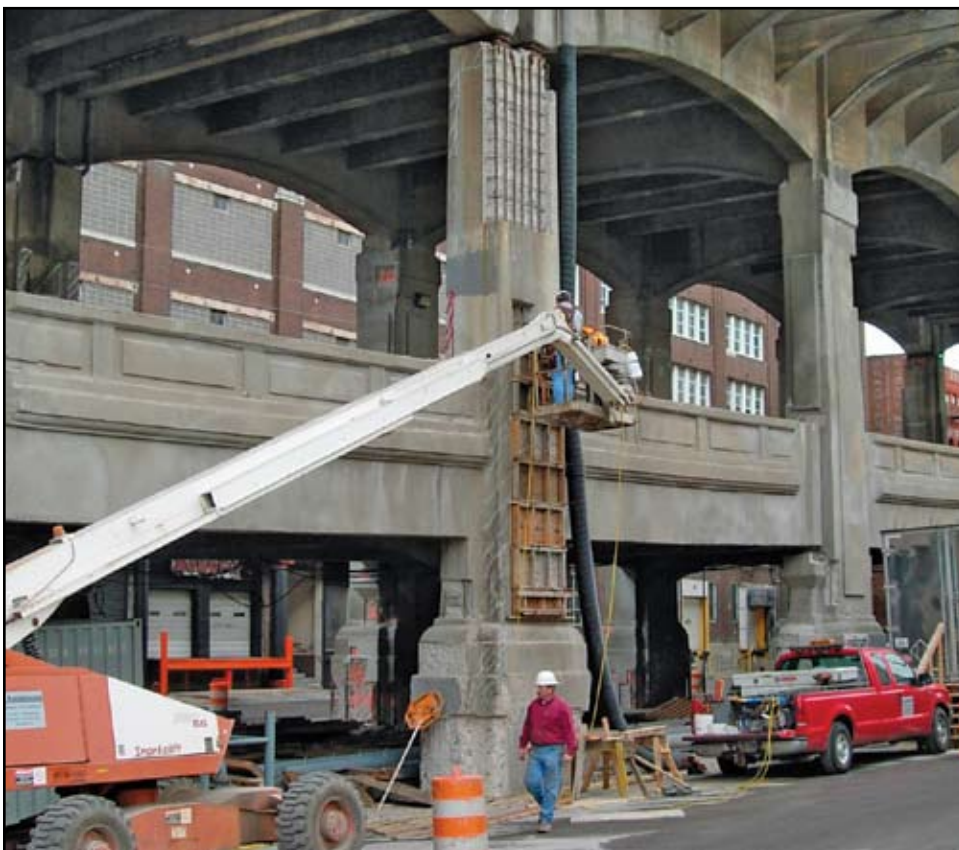
Concrete repairs completed prior to installation of ECE treatment. Courtesy of Vector Corrosion Technologies.

To prepare the structure for ECE installation, all existing concrete delaminations and spalls were repaired with a cement based repair mortar. All cracks in the concrete were repaired or sealed to prevent direct contact between the electrolyte (water) and the rebar, hence reducing the possibility of an electrical short.

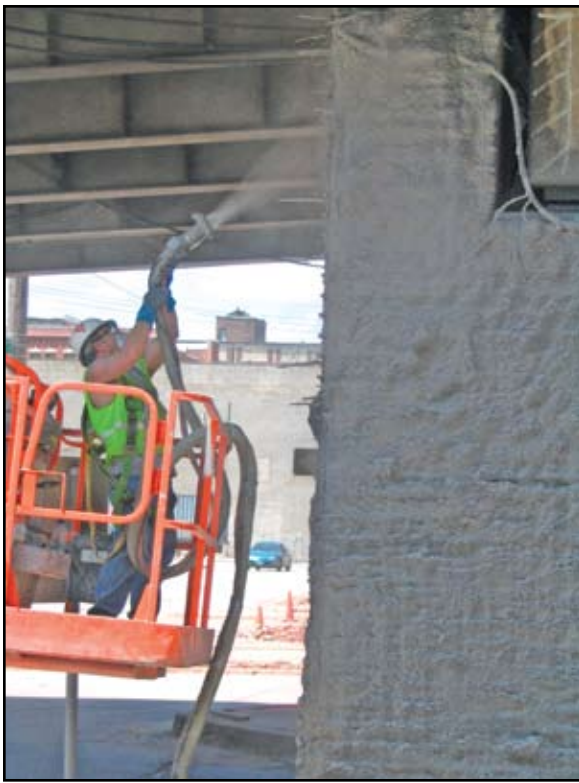
Application of cellulose fiber for conductive media around temporary anode. Courtesy of TransSystems.

The steel mesh was then encapsulated in a wet spray-applied cellulose fiber/hydrated lime mixture. Hydrated lime powder was added to the cellulose fiber at a rate of 10% by weight. The lime and cellulose fiber were thoroughly mixed in the hopper of the fiber blower and then dry-blown through the hose. Water was injected at the nozzle to create a saturated mixture that sticks to the concrete and mesh. The fiber acts as a conductive media that distributes the current uniformly over the surface of the concrete.

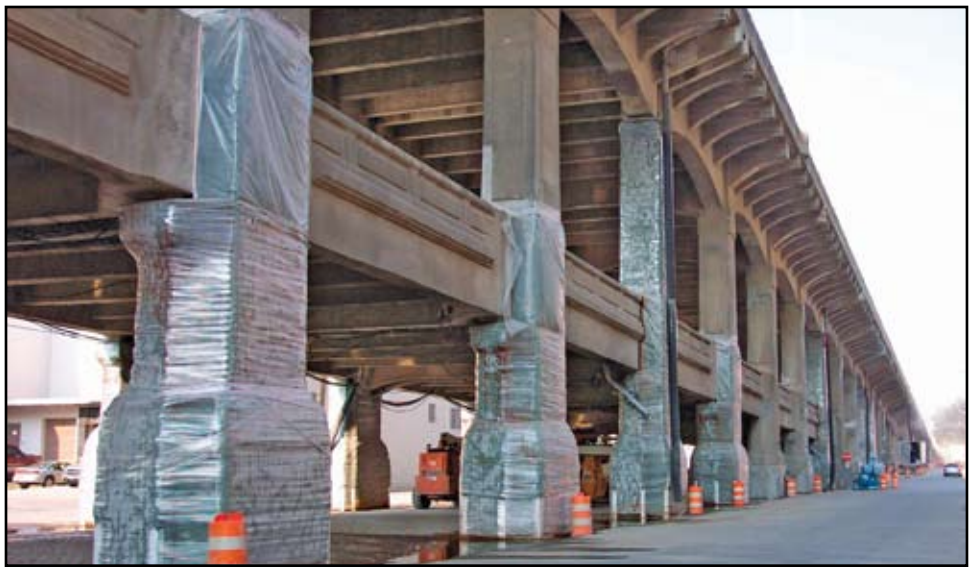
Several piers undergoing ECE treatment process. Courtesy of Vector Corrosion Technologies.

The rectifier was then switched on and operated in the constant voltage mode. The DC output was set as high as possible, but not to exceed 40 V and/or 0.2 A/square foot of concrete surface area. As each rectifier was turned on, the cables running into the junction boxes were tested to ensure correct polarity. During the time the system was running, electrical measurements and system inspections and adjustments were conducted on an on-going basis.

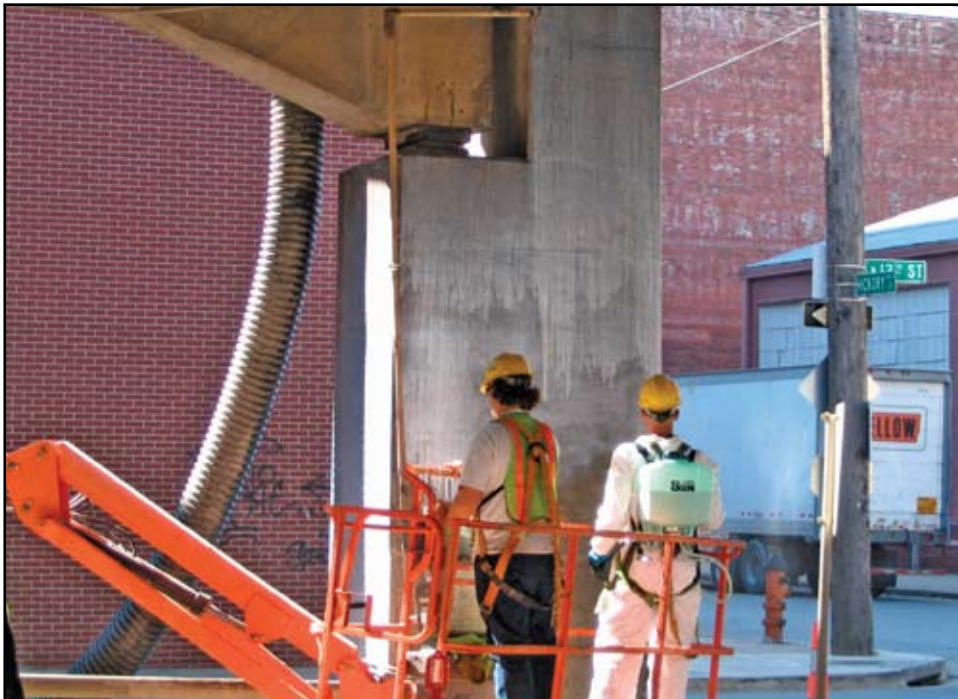
Application of concrete sealer to prevent future chloride contamination after ECE treatment is completed. Courtesy of TranSystems.

Once the chloride content has been reduced to acceptable levels, and the pH of the concrete surrounding the reinforcing steel has been raised, the temporary anode and electrolyte media is removed. After the treatment is complete, barrier protection is provided by the application of a clear concrete sealer to prevent future chloride contamination.
