Hurricane Katrina US&R Deployment

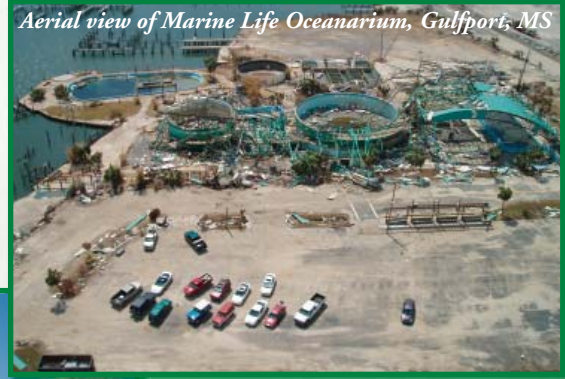
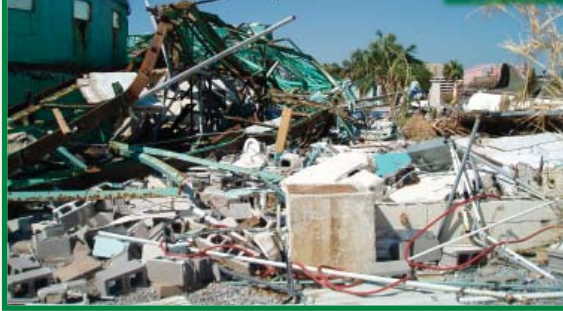
Main tank to left with Aqua Stadium cover in background, remains of gift shop in foreground

The photographs show damage done to the Marine Life Oceanarium located on the Gulfport waterfront. The multiple roof structures over the main tank and the Aqua Stadium were destroyed by wind and waves. The ground level view shows the twisted roof framing as well as the remains of the gift shop in the foreground. After assessing the ground-level and overhead hazards, the author had the opportunity to step back and consider the cause of such damage. It appeared, given the brief study here as well as other locations, that a significant wave came ashore in addition to the storm surge. One example of this was the concrete bleachers at the Aqua Stadium, which were dislodged from their supports.

The impact of the water on the shoreline structures is an interesting engineering issue. There were anecdotal stories that a wave over 10 meters tall struck the shore line in Mississippi. Perhaps such a wave struck the Oceanarium, resulting in the complete destruction of the roof framing. The Naval Research Laboratory reported in August 2005 that a wave 80 feet above the ocean's surface was recorded during Hurricane Ivan in September 2004. This raises the possibility that Hurricanes can generate large waves in addition to the storm surge and high winds. Engineers designing hurricane-resistant structures along shore lines may need to consider, in addition to the wind loads, the impact of large waves on buildings. ■

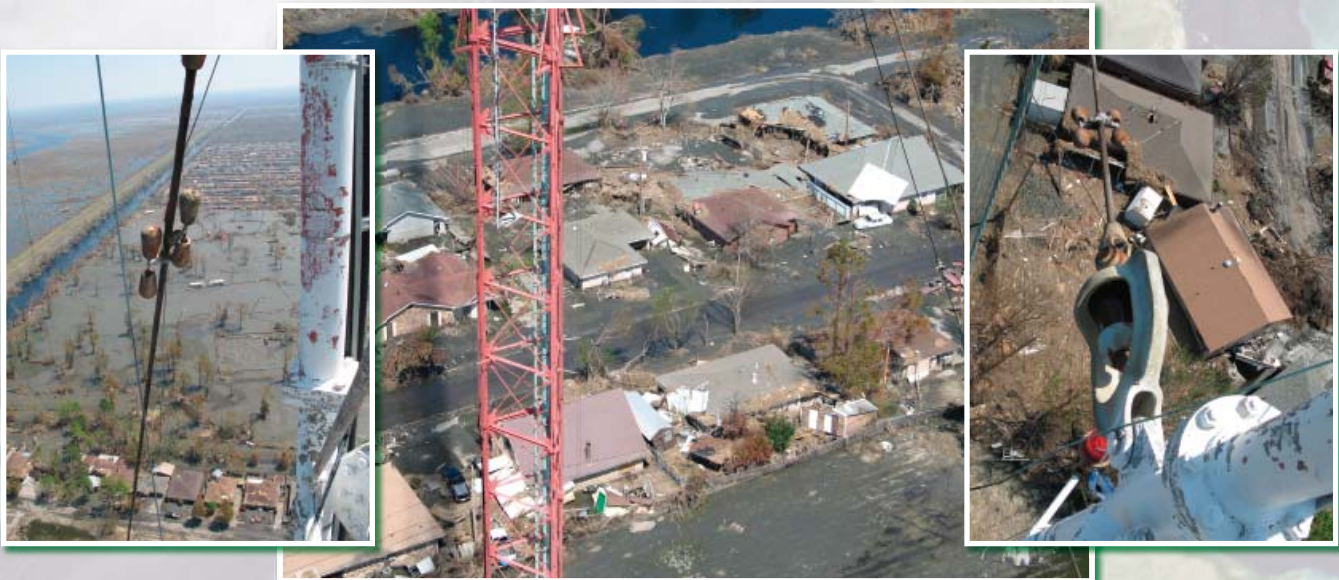
Flood damaged Chalmette neighborhood of New Orleans, LA
