# Repair of Unbonded Single-Strand Tendons

By Gail S. Kelley

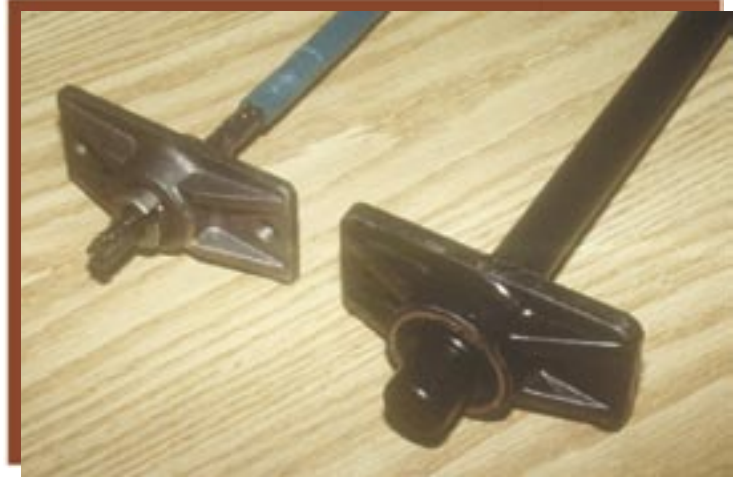
*Fixed-end anchors. Anchor on the left is non-encapsulated. Anchor on the right is encapsulated.*

ACI 318 defines an unbonded tendon as the complete assembly consisting of anchorages, prestressing steel with coating, and sheathing. The prestressing steel used for monostrand tendons in building construction is usually 1/2-inch diameter, seven-wire, 270 ksi strand. The standard anchorage consists of a rectangular cast-iron plate and a two-piece wedge.

When a tendon is less than 120 feet, it is typically only stressed from one end. The anchorage at one end (the fixed-end anchorage) is attached when the tendon is fabricated. The anchorage plate for the other end (the stressing-end anchorage) is nailed to the edge form, along with a plastic pocket former that creates a recess for the anchorage. The tendon is rolled out on the formwork and the strand is pushed through the stressing-end anchorage before the concrete is placed. After the concrete has reached the strength required for post-tensioning, wedges are placed in the stressing-end anchorage and the strand is stressed to 80% of its ultimate strength. When the strand is subsequently released, the wedges are pulled into the anchorage plate until they lock the stressed strand in place.

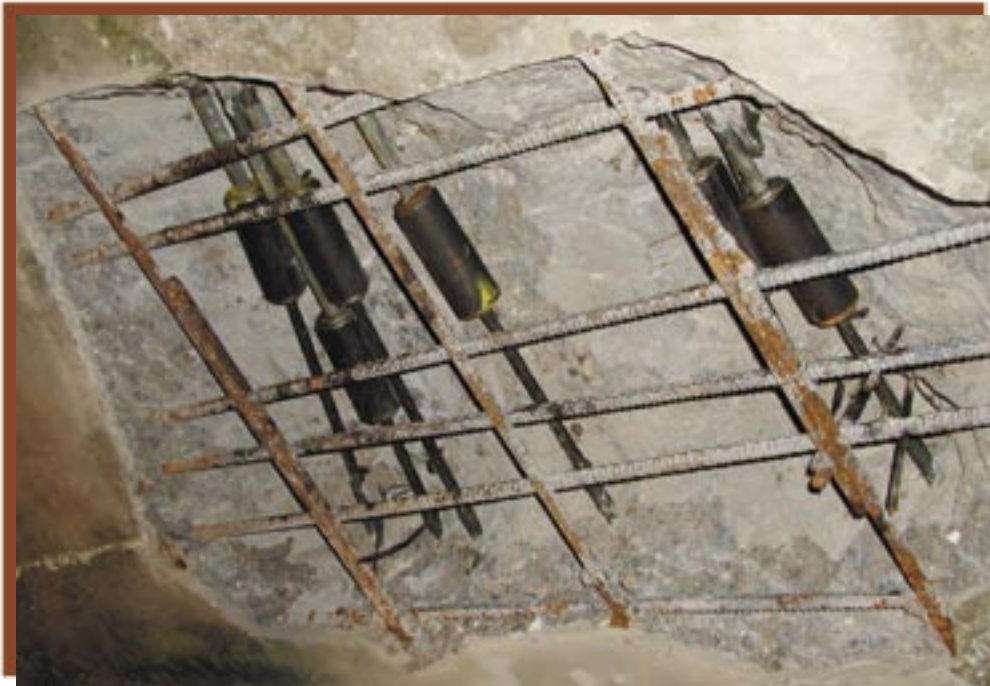
*Splice chucks in a partial-depth overhead access hole.*

The two basic types of hardware used in repairs are barrel couplers, also called splice chucks, and in-line stressing couplers, also called by their trade name, lok-couplers. A splice chuck simply connects two pieces of strand together. The most commonly used splice chuck consists of a short metal pipe with a set of wedges at each end. The existing strand is inserted into one end of the metal pipe; the new strand is inserted into the other end. When the tendon is restressed, the wedges at the each end of the coupler join the two pieces of strand.

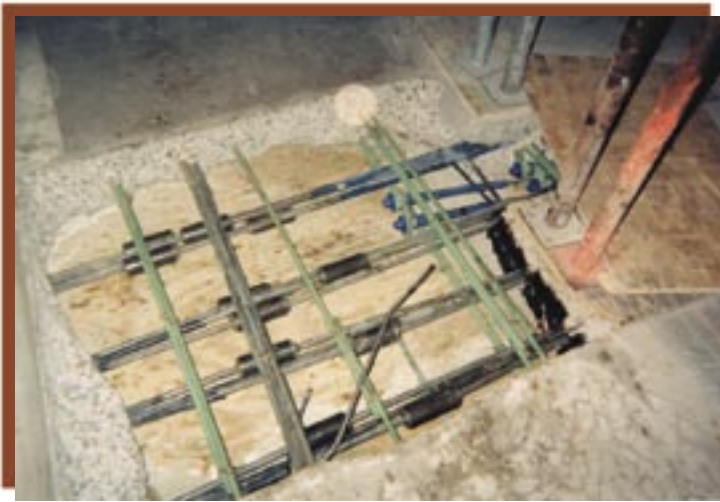
Splice chucks in full-depth access hole. Anchors on the right are fixed-end anchors for partial-length tendons.

In the simplest tendon layouts, all of the tendons run the entire length or width of the building. However, additional partial-length tendons are often required in the exterior bays of both one- and two-way slabs to make up for the reduction in tendon drape. The drape in the exterior bays is reduced because the anchorages must be at the mid-depth of the slab to avoid applying a moment to the slab edge. In addition, increased cover may be required at the low point of the exterior bay for fire protection.
