# HISTORIC STONE ARCH REQUIRES MODERN APPROACH

BY MATT LEWELLYN, P.E.

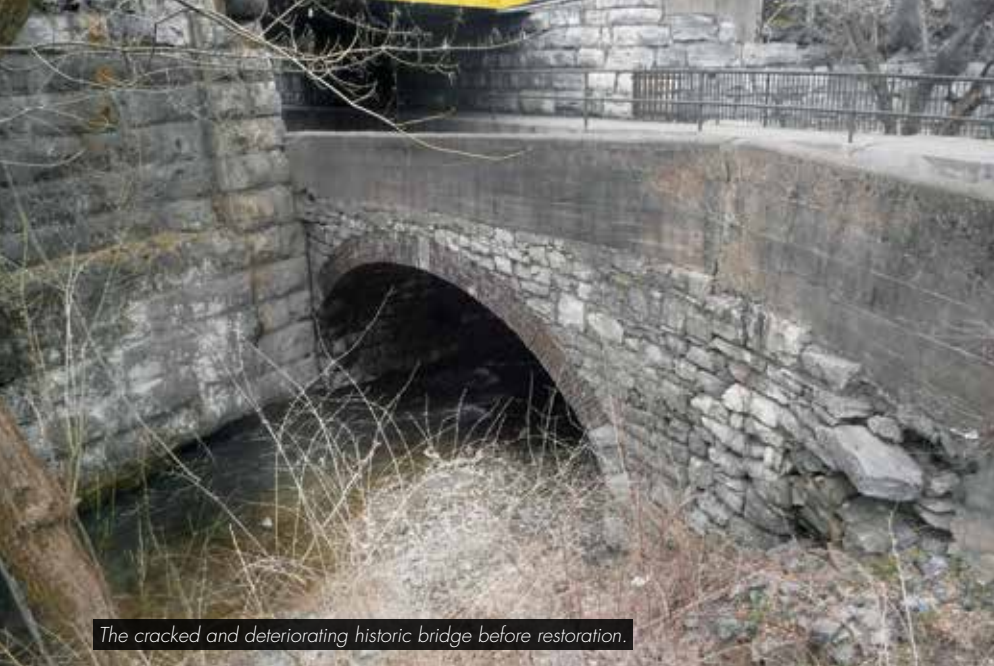
The cracked and deteriorating historic bridge before restoration.

Structural deficiencies, including unstable wingwalls, loss of mortar, sidewalk settlement, and missing, cracking, or loose stones were identified in 2010. As a result, the City of Martinsburg and the West Virginia Department of Transportation (WVDOT) sought a solution that would increase load capacity while retaining the historic aspects of the structure. This required a phased and tailored approach that allowed the team to work around the delicate condition of the historic parts of the bridge.

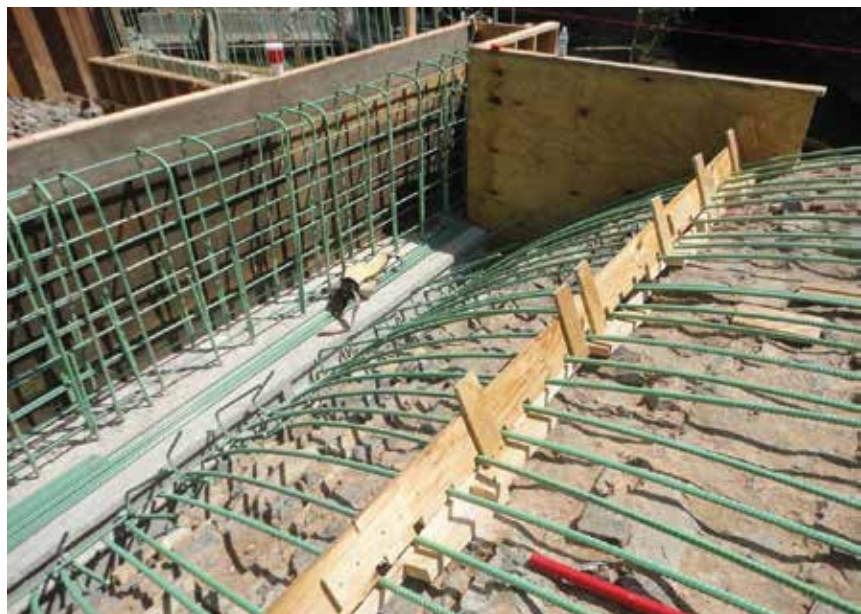
A new reinforced concrete arch was designed and placed over the top of the existing arch to provide full live load capacity.

The project team's goal was to maintain the existing stone arch while providing an alternate structural system to carry traffic loads. A rigid frame was constructed in direct contact above the stone arch to accomplish this. The rigid frame system consists of a concrete rib that follows the existing arch line and a concrete slab that functions as the roadway surface for the bridge. The new frame was constructed by installing falsework under the existing arch barrel, removing the wearing surface and earth fill, and then constructing the new frame on top of the existing arch.

The contractor's falsework was a series of steel W16 beams, couplers, and posts with diagonal bracing, which supported 3-inch-thick timber planking placed just below the stonework. After mats of epoxy coated rebar were tied into place, the arch rib was formed and poured directly on top of the existing stone barrel. The concrete rib was bonded to the stone using an epoxy bonding agent, applied before the pour. Next, gravel fill was installed to fill the voids within the concrete frame, and the concrete slab was constructed on top

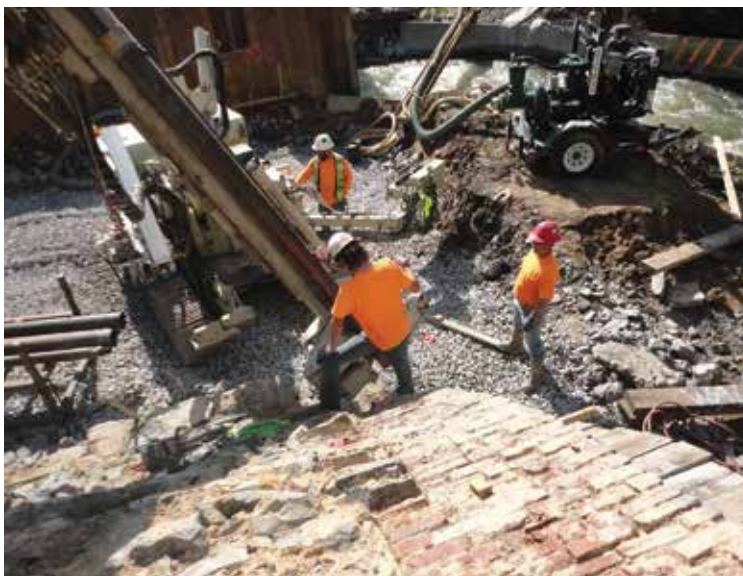
Burgess & Niple designed the bridge with micropiles instead of hammer-driven piles to reduce vibrations adjacent to the existing stone masonry.

Sensitive ground conditions, steeply sloped bedrock, and adjacent structures made micropiles a good option for the East Burke Street Bridge. A total of 41 micropiles support the forward abutment and parallel wingwalls. Load testing was performed to confirm that the maximum factored axial load of 154,000 pounds per pile would be adequately developed. The rear abutment is founded on a spread footing placed directly on the bedrock.

Several of the 7 $\frac{3}{8}$ -inch-diameter micropiles were installed at an angle to accommodate both axial and lateral loads. The outer casing pipe and drill rods advance through overburdened soils to rock and continue to pile tip elevation. Drill rods and casing were added in 5- or 10-foot lengths. Drill cuttings travel up the inside of the casing using air and water and are discharged through a swivel on the drill head. The piles penetrate 10 feet into bedrock to provide the bond zone for the grout, which is placed through a 1-inch high-density polyethylene (HDPE) tremie pipe to the bottom of the hole. A single number 11 reinforcing all-thread bar (Grade 75) was placed in the middle of the micropile.

The micropiles provided a strong foundation without using a more traditional driven steel H-pile that could have shaken the ground and caused damage to the stone arch barrel, which would be temporarily supported but still vulnerable to heavy vibration.

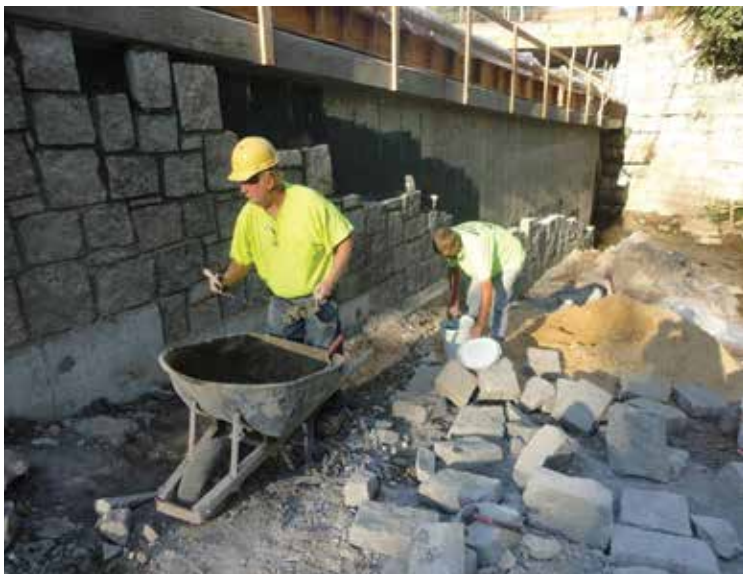
The refurbished bridge used stone facing over the wingwalls and black metal fencing to create a similar aesthetic

assess the condition of the material and arch structure and helped preserve as much of the viable stonework as possible. As a result, the arch barrel was cleaned and repaired with a lime mortar mix, cracked stones were repaired, and missing or damaged stones and bricks were replaced. In addition, the new concrete spandrel walls, wingwalls, and barriers were faced with stone masonry, some of which were reused from the existing walls. Thus, using the scan helped sustain as much of the bridge's history and character as possible.

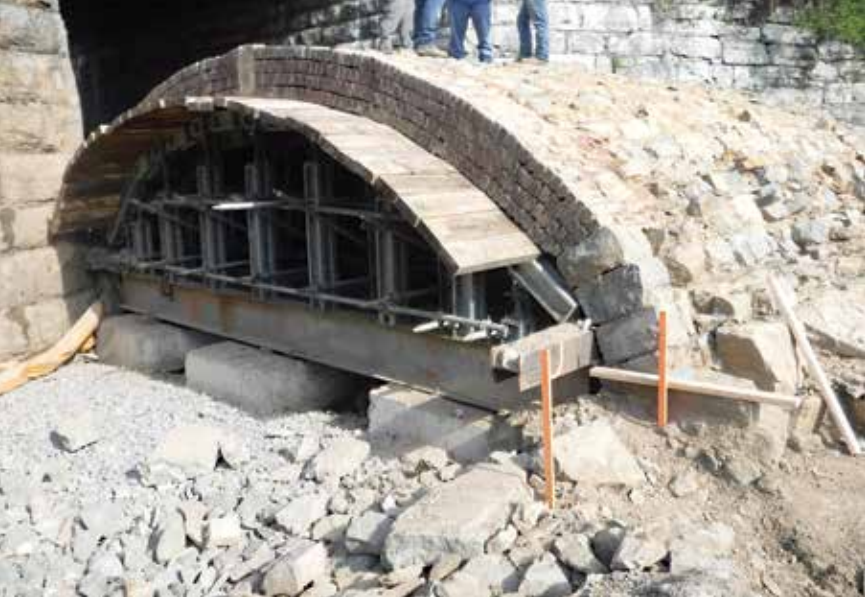
The East Burke Street Bridge arch as it is unearthed.

As the arch was unearthed, additional issues were discovered. Predictions made about the width of the existing foundation stones were not accurate. The stones were much larger and conflicted with the placement of the concrete foundation as designed. Trimming the stones was discussed, but the team decided not to risk disturbing the arch. Instead, Burgess and Niple adjusted the structural model to account for thrust of the larger span, and revised plans were issued to keep the project moving. This required three additional micropiles and additional battering of the piles.

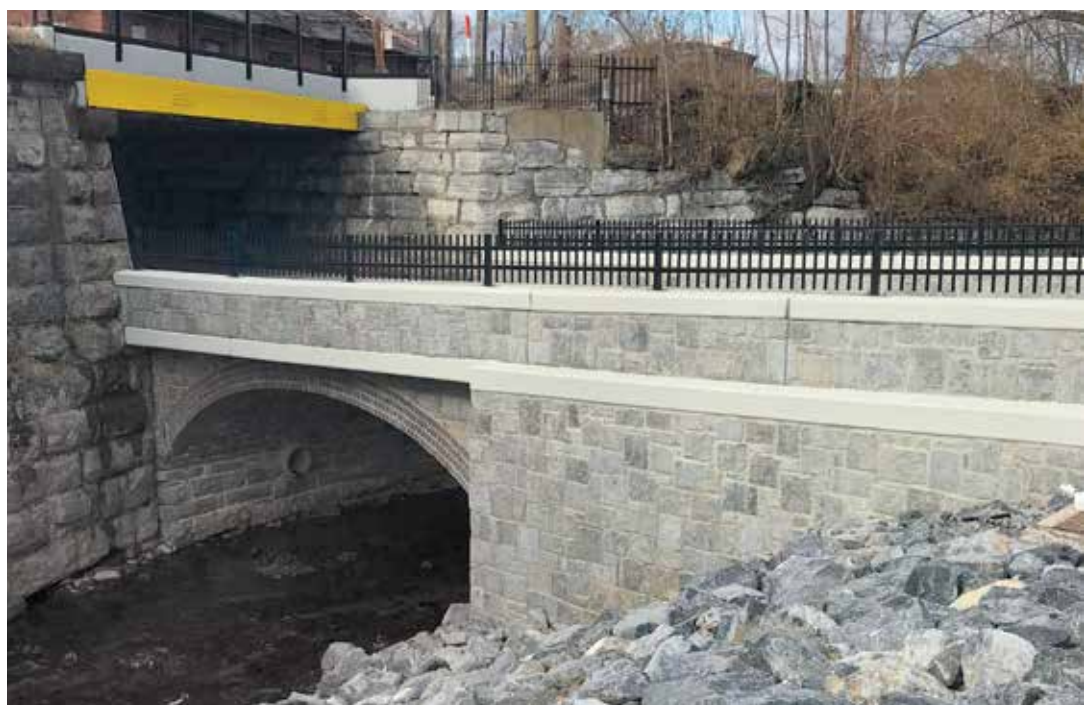
The East Burke Street Bridge following the renovation.
