# MOYNIHAN TRAIN HALL

## A NEW ERA FOR THE JAMES A. FARLEY BUILDING

By Brian A. Falconer, P.E., S.E., and Ick Kim, P.E.

Redevelopment transforms an outwardly grand but mostly functional 20<sup>th</sup>-century postal building into a 21<sup>st</sup>-century transportation hub that is elegant, both inside and out.

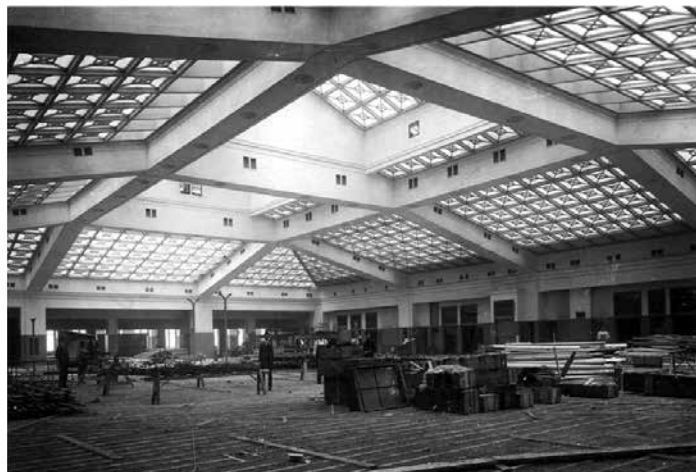
Mail sorting room – looking Southwest.

Beyond its Beaux-Arts exterior and ornate retail post office, the Farley Building is, for the most part, more function than form. The mail sorting room was for post office employees and not a public space. Its floor was two levels above the tracks, only one level below the trusses, and the long clear spans afforded workers the flexibility needed for sorting racks, carts, conveyor belts, pneumatic tubes, and other equipment; in practice, the space was quite cluttered. The skylights were pragmatic, providing ample lighting from the sun but not intended as aesthetic elements. A ceiling of filigreed diffusers closely followed the truss bottom chords where viewing galleries were concealed, along with the full depth of the trusses. Removing the mail room floor and most of the existing roof, combined with

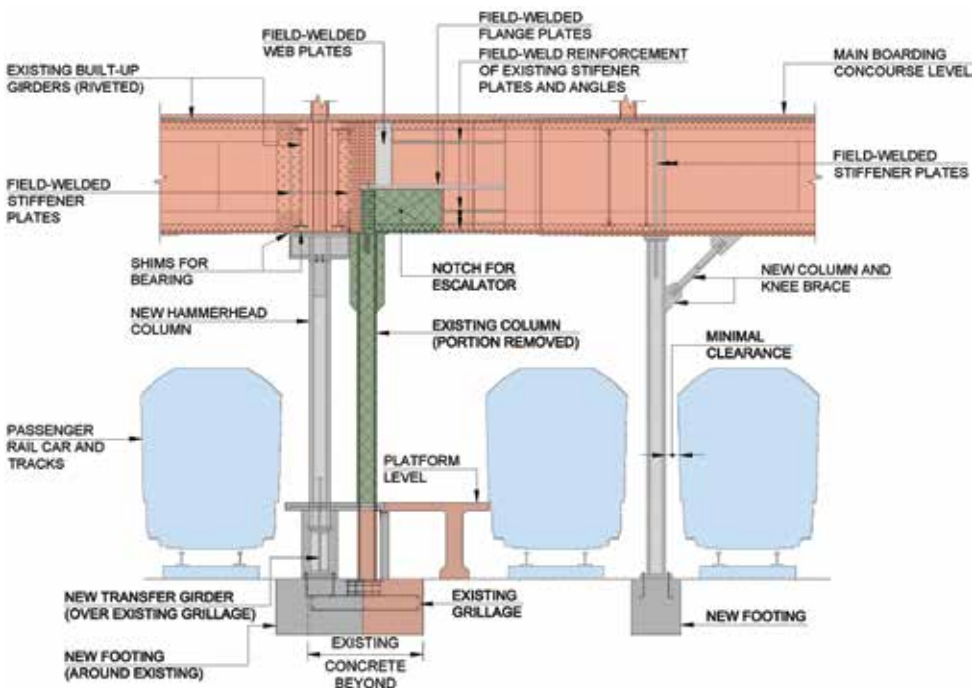
Main boarding concourse – section at girder.

The existing trusses had sufficient capacity to carry a new roof – the loading would be essentially unchanged. However, all existing framing between the trusses had to be removed to maximize the skylights' function and appearance. This left them unbraced at their ends and for the full length of their gabled top chords. Restoring the trusses' stability was a central component of the structural design by Severud Associates.

Each truss is composed of two identical and parallel bents, spaced about three feet apart, initially to form an observation gallery for postal inspectors. The bents are tied together with diaphragm plates and latticed straps that terminate about six feet above the bottom chords. A box beam 36 inches wide by 24 inches deep, composed of 3.5-inch-thick steel plates and located along the top of each truss, provides sufficient lateral support without extending beyond the width of the existing chord members. The box beams also deliver lateral loads from the skylights to the ends of the trusses and eliminate the need to provide bracing between them.

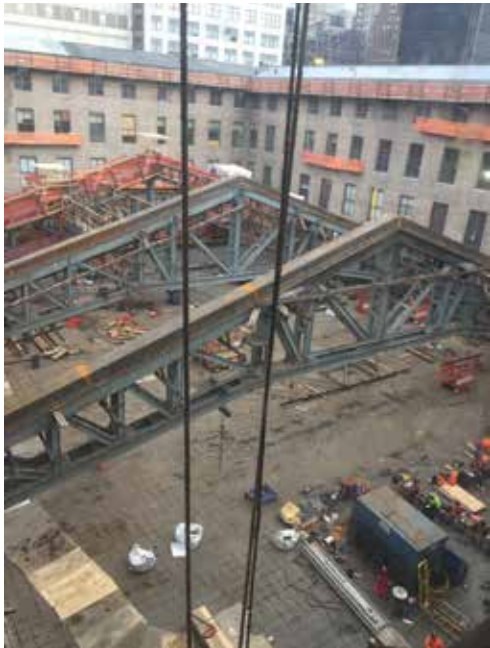
Existing trusses and reinforcement.

The trusses required additional reinforcements to maintain stability under the skylight loading. First, diaphragm plates were welded between each pair of existing truss bents, at the top of the top chords and just below them. Next, diagonal bracing plates were welded to

the diaphragms to prevent rotation where the bracing cables connect. Finally, plates were welded to tie together pairs of truss bottom chords at each panel point to replace the removed gallery framing. Existing double-bent trusses also frame the perimeter of the train hall and, as the main trusses, serve as observation corridors. They support the low roof between the skylights and Farley Building office wings and are now exposed to view. With a uniform horizontal profile but located at about the main truss bottom chord level, the perimeter trusses are too low to support the new skylights. So instead, existing columns were extended up to the box beam elevation, and new framing was installed between them. At the ends of the box beams, steel tube diagonals were welded from each side, down to the first perimeter truss panel point, to prevent rotation and transfer lateral loads into the building frame.

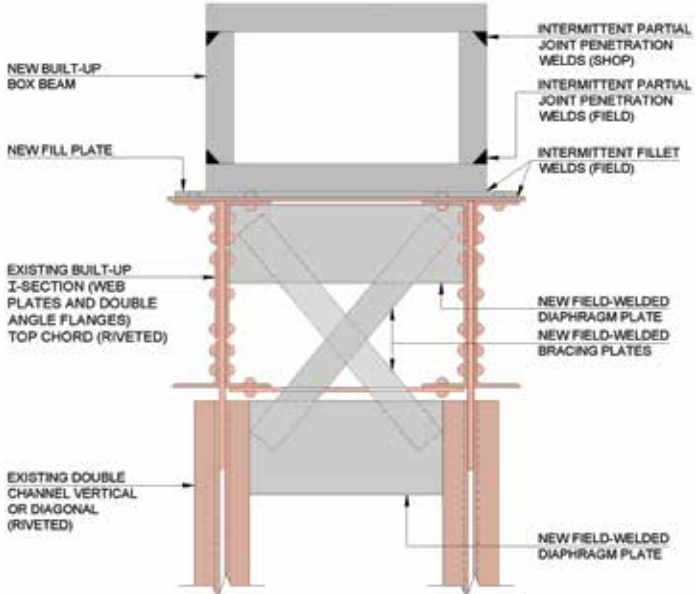
Main boarding concourse – truss top chord section.

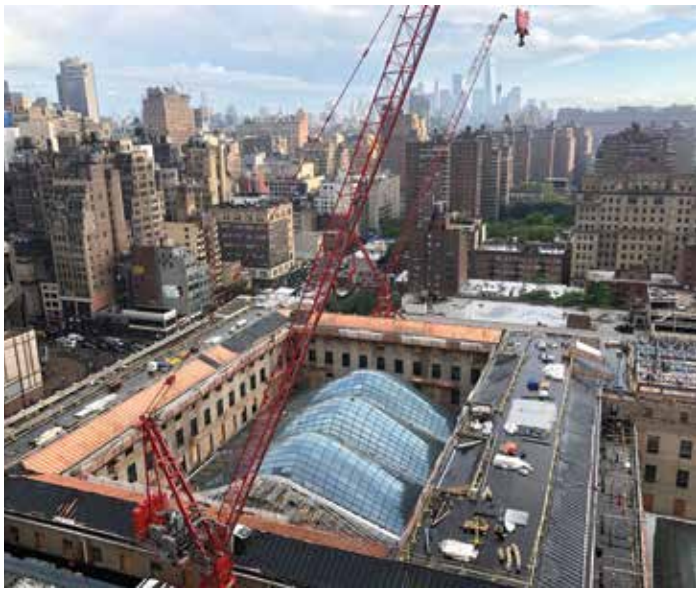
Main boarding concourse skylight installation.

The skylights were designed by SOM in collaboration with schlaich bergemann partner, structural engineers. Four modules, each measuring 50 feet by 150 feet and arched in cross-section, follow the gabled truss top chords to enclose the concourse. The structures are lightweight grids of steel tees that vary in depth and are spaced with three to four feet between them. The frameworks are internally braced with in-plane diagonal cables and transverse "spider webs" of cables at the existing truss third points.

Demolishing the existing sorting room floor created a lofty space and a logistical challenge: the highest point of the skylights is 92 feet above concourse level. In response, Skanska, who, with Vornado Realty Trust and The Related Companies formed the developer-builder team, created a temporary intermediate platform 30 feet above the concourse level to facilitate reinforcement of the existing roof trusses and installation of the skylight components. The platform was designed to withstand all working loads, including the scaffold frame that held the skylight segments in place during installation, and provided workers with a secure environment while also protecting personnel below. As a result, contractors could perform multiple scopes of work simultaneously, with the added benefit of significant cost and schedule savings.

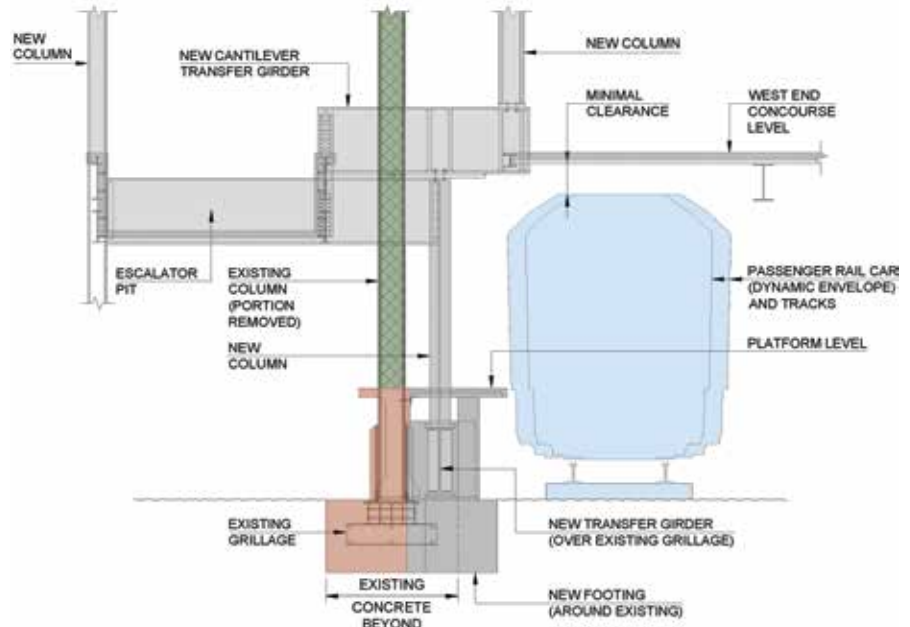
West end concourse – section at escalator pit.

The existing concourse level framing consists of nine-foot-deep, riveted steel plate girders spaced at 20-foot intervals and spanning up to 70 feet in the north-south direction, perpendicular to the platforms. Because the concourse framing transferred the weight of the demolished floor over the tracks, its capacity increased proportionally – enough to support the new concourse loading without global reinforcement. However, the openings necessary for escalators – rectangular, with the long direction parallel to the platforms and hence, perpendicular to the girders – interrupt the direct load path to existing columns. Therefore, existing girders had to be cut and new transfer girders installed.

The clearances for the escalator trusses and headroom meant that notches had to be cut in the top or bottom (respectively) of existing girders. At each notch, new flange plates were welded on both sides of the existing web, and the remaining flange elements – double angles and cover plates – were welded to each other and the web. Where new loads exceeded the shear capacity of the existing web, additional web plates were added, usually extending beyond the notch to provide a transition from the full-depth to notched section.

At the ends of girders, reinforcement of the notches was usually sufficient to restore capacity and deliver loads to existing columns. Conversely, a new column was necessary where a notch occurred at a girder's mid-span. At these locations, a new footing was placed underneath the existing platform, and a column was erected and shimmed tight to the underside of the girder before the notch was cut.
