Ambassador Bridge Redecking Fosters Growth between Nations

By Michael Borzok, P.E.

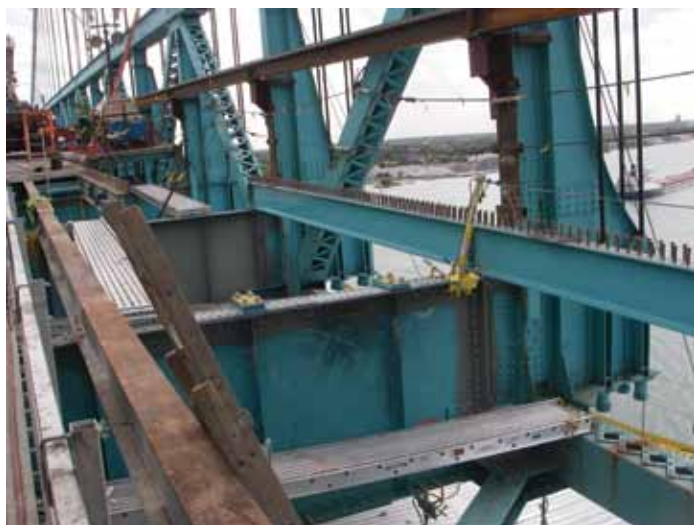
Deck replacement of the suspended spans included installation of new steel stringers.

The deck was removed in 145-foot sections using a gantry crane to lift and remove each piece. Once the deck was lifted away, construction teams could remove old stringers and perform repairs to floorbeams, a majority of which could not be accessed with stringers still in place. New stringers were then installed, followed by the placement of new steel grid panels, which were then filled with concrete. As noted previously, a combination of lightweight, normal weight and heavyweight concrete was used across the four phases to maintain balance and prevent any alterations to the bridge's geometry. This process was repeated for each phase of the construction process, with stages one and four requiring the additional step of installing open railings on either side of the bridge. The fourth phase of redecking was finalized in May 2012, and construction teams are expected to remain on site until the end of the summer to perform clean-up work.

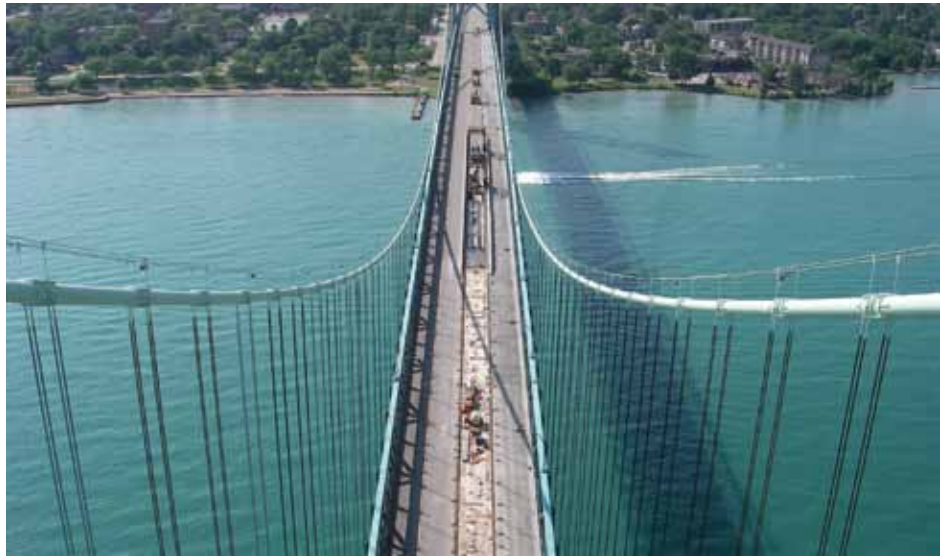
The rehabilitation of the suspended spans was performed in stages.

Another challenge involved traffic flow during the construction stages. Since so much commerce relies on this crossing, it was essential that traffic continue moving throughout the entirety of the redecking contact. The project was broken into four stages, which would allow for three of the four traffic lanes to remain open at all times, as required by the DIBC.

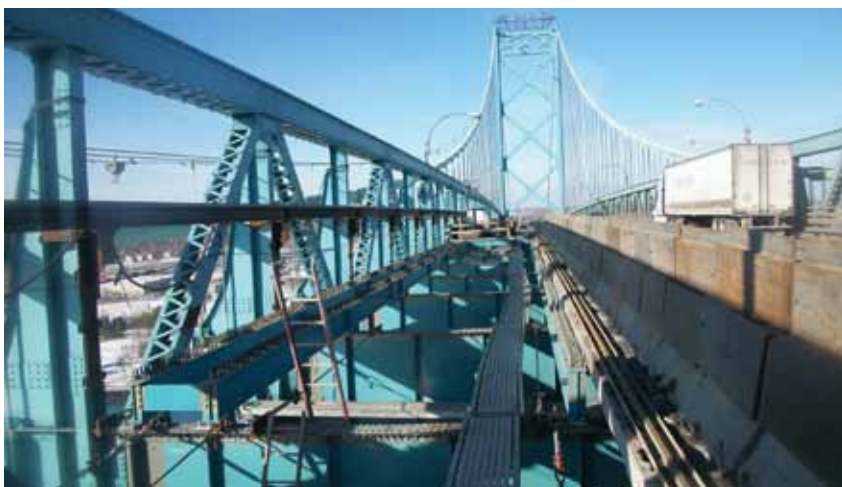
Staged construction was used to help maintain traffic.
