# Westside Pavilion

Seismic Retrofit for a Pre-Northridge  
Moment Frame Building

By Bill Williams, P.E., S.E.  
and Arvind Nerurkar, P.E., S.E.

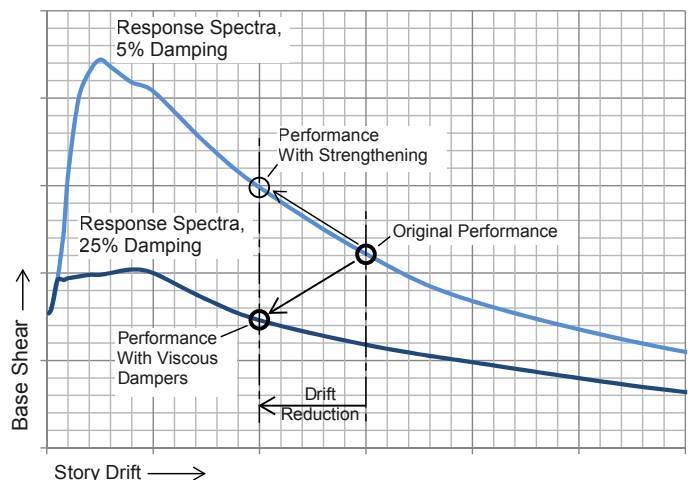
Figure 1: Retrofit performance comparison. Note that while both damping and strengthening reduce drift, only damping reduces drift while simultaneously reducing base shear.

the associated structural demands encountered in strengthening systems (Figure 1). This ability is critical, for projects of this type, to avoid extensive foundation upgrades. Foundation upgrades would have been prohibitively expensive and severely disruptive to the operation of the store.

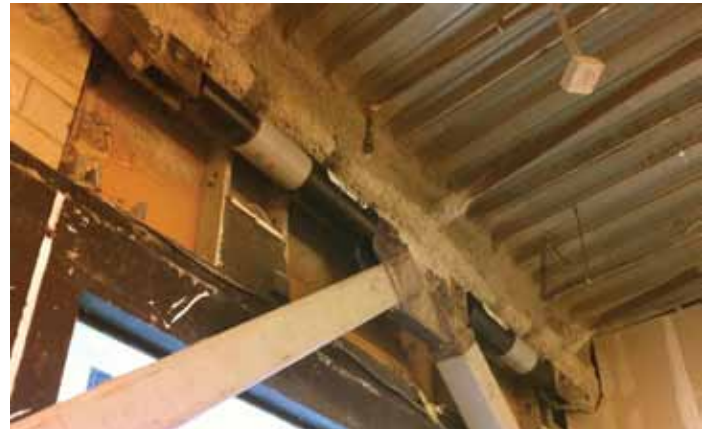
Analysis and design was performed using ASCE 41 *Seismic Rehabilitation of Existing Buildings*. Based on the analysis, a retrofit design was produced consisting of the installation of 32 viscous dampers on two of the three stories. Each damper was selected and fabricated to deliver 220 kips of damping force at peak velocity. With the added damping, the interstory drift is anticipated to be reduced to design target levels, and the demand on the existing pre-Northridge connections would fall well within acceptable levels.

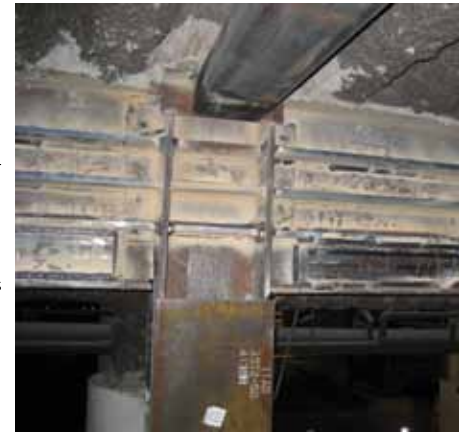
Figure 3: Typical drag retrofit connection.

The effective installation of the dampers required a significant upgrade to the beams and connections in the collector system. ASCE 41 requires that all of the elements in the damper load path be designed to remain elastic during the design events. The existing connections were single row bolted shear tabs and did not have sufficient capacity to resist the loads from the dampers. In order to upgrade them, tie plates were welded to the beam web and supporting column or beam (Figure

3). These tie plates were designed to carry the entire collector design load, leaving the original connection to resist shear. These tie plates were located as close to the centerline of the beam as possible to minimize the potential effects of added rotational restraint. The collector beams were also refitted with added plate, tee, and HSS sections to improve their compressive capacity. Because the dampers were installed on the perimeter of the building, in some locations the existing diaphragm was not capable of transferring the load between the dampers and the existing drag system on the interior column lines. In several locations, HSS bracing was installed to transfer these loads directly.

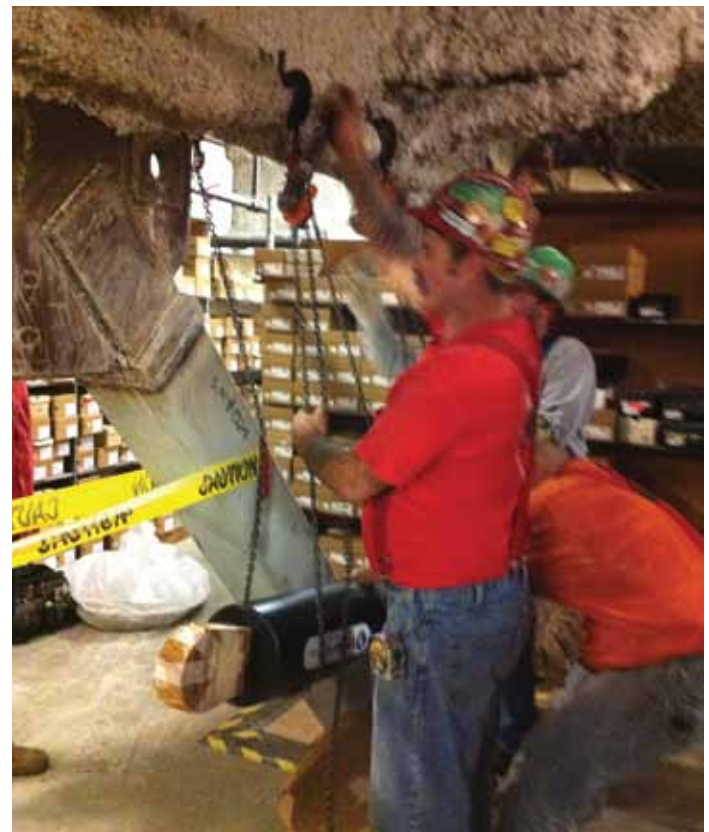
Figure 4: Installation of the viscous dampers by hand. Each damper weighs 500 pounds.

Steel had to be moved and installed by hand due to the limited space and access in the operational building (Figure 4). In many cases, the welding involved had to be performed in extremely tight quarters. Often, details were reworked on the fly by the structural engineer in order to allow the contractor to complete the work. These collector retrofits, and the difficulty in building them, represented the vast majority of the complexity in the construction of the retrofit.
