Collaboration and Innovation Lead to 3rd Service Life for an Iconic Iron Bridge

By Rich Johnson, P.E. and Steve Olson, Ph.D., P.E.

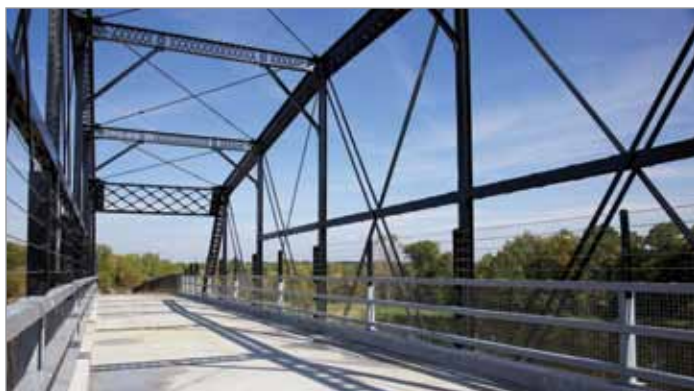
Cross bracing, verticals, diagonals and counters.

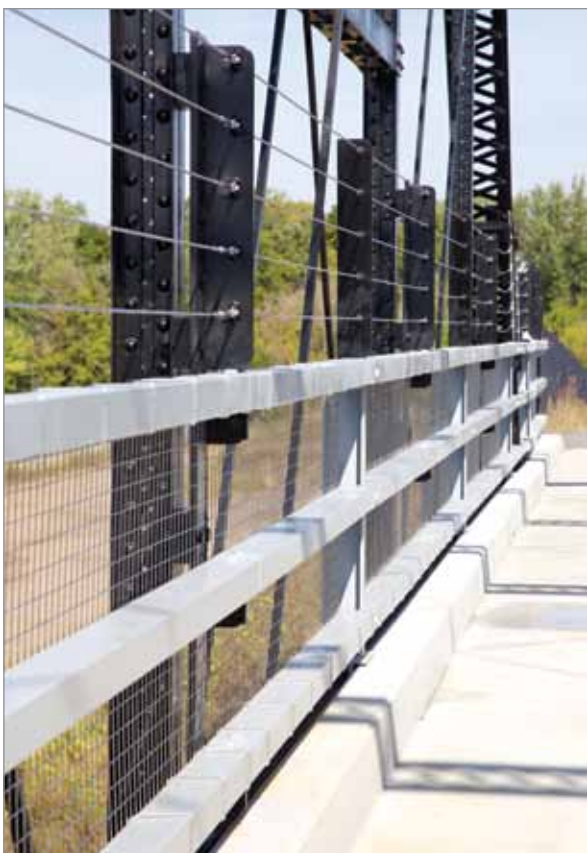
Railing details.

Three horizontal rails from the second bridge site were re-used at the third site. The top re-used rail was set at 54 inches, which is the typical

height of bicycle railings in Minnesota. The other two rails were evenly spaced below the top rail and the curb, much as they were at the second site.

A stainless steel mesh was placed behind the rails to limit the potential for debris to reach the roadway below the bridge. Above the top rail, stainless steel marine cables were installed on a 6-inch spacing to provide an 84-inch tall railing for equestrian trail users.

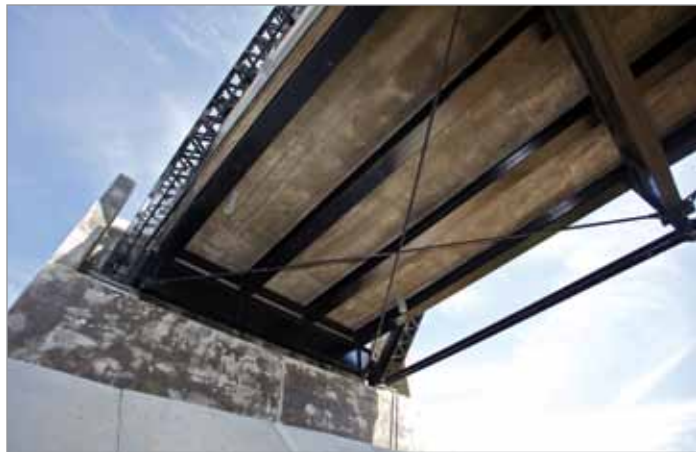
Below deck, stringers, sway bracing at abutment.

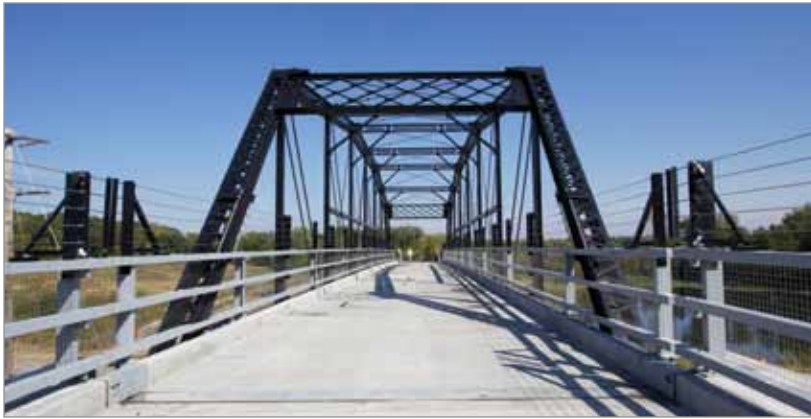
Portal frame.

The need for replacement end floor beams, replacement portal members and replacement stringers was expected from the start. But the need to replace 8 of the 96 primary eyebars, as well as the need to fix an interior floor beam and several top chord members, had not been anticipated when the re-assembly contract was let.
