The 100 Stockton Street project reimagines an eight-story former department store into a multi-use office, dining, event space, and boutique retail building. This reimagination of the building required significant structural shoring to facilitate the design.

SHORING *Facilitating* DESIGN at 100 STOCKTON

By Robert Graff, S.E.

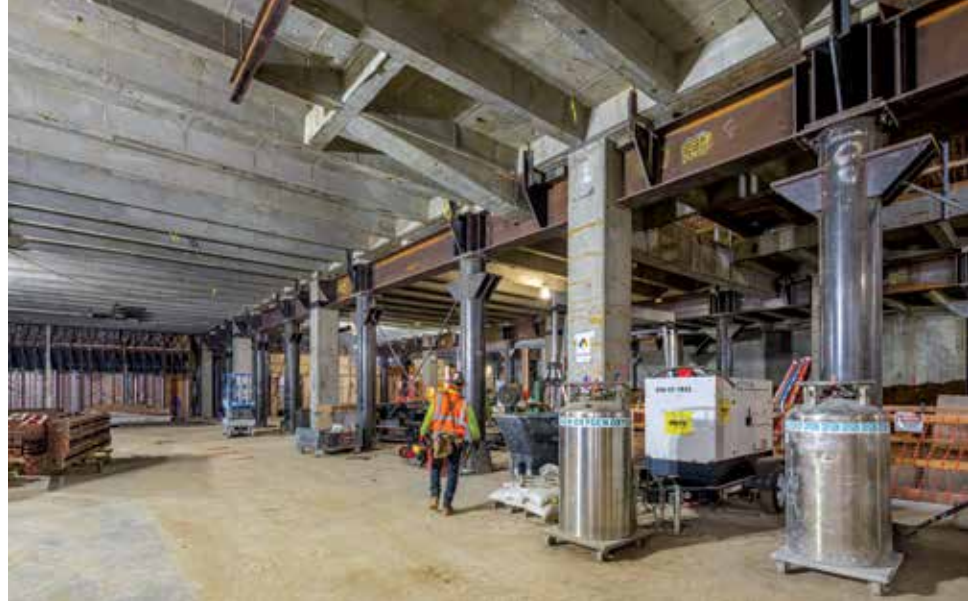
Figure 2. Completed shoring columns and beams prior to column demolition.

In their temporary de-stressed state, the PT girders could not support the joists and slab with only the mild steel reinforcement they possessed. Shoring beams placed on top of the column shores provided nearly continuous support during the girder's extremely weakened state. Shoring beam deflections were calculated while supporting the load of the slab, joists, and de-stressed girders. Due to a temporary condition, the deflections would become locked in when the new columns and walls supporting the slab were cast. Detailed checks of the steel shoring beams were completed to control deflections within acceptable limits resulting in stiff W27×146 beams (Figure 2, page 23).

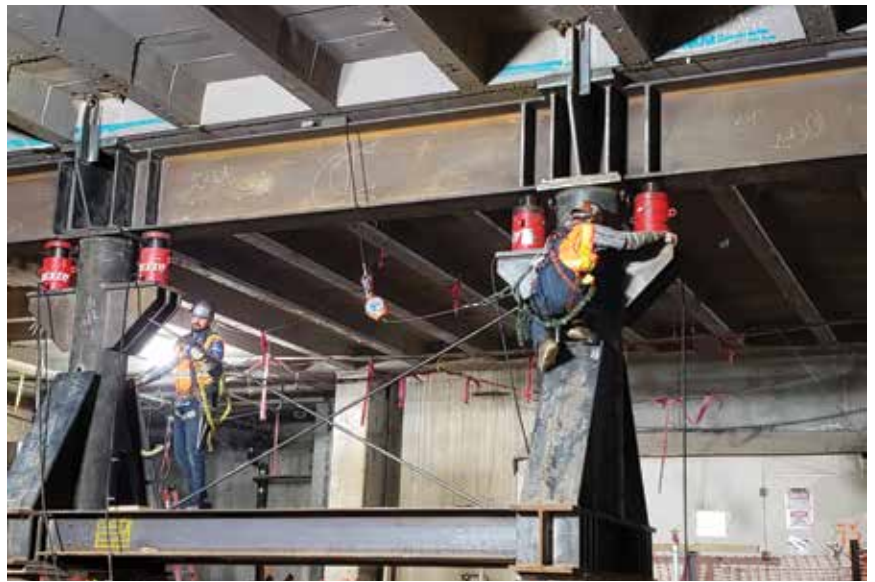
Figure 3. Setting up for test lift.

1000 kips maximum per column and had four jacks to lift the load (Figure 3). The jacks were incrementally increased in load, and the building was inspected for signs of damage at each increment. A surveyor monitored the structure for movement, providing real-time feedback. Arriving at nearly 800 kips, the surveyor recorded that the building column had moved $\frac{1}{16}$ of an inch upward, and the shoring system had deflected $\frac{5}{8}$ inch at the shoring columns. The shores were shimmed using stacks of steel plates between the shoring column and beam to lock in the load before releasing the jacks. The building had no damage, and the full load was now supported on the shores. With the successful test, the remaining bays could be jacked to transfer the building loads from the columns to the shores, and column demo proceeded.

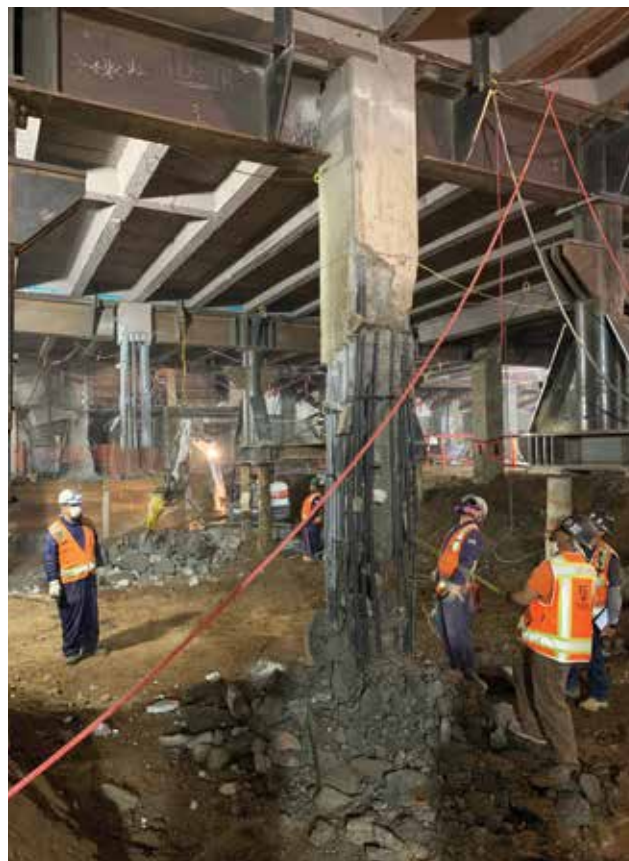
Figure 4. Column demolition with bars buckling.

Column demo started with a text of the picture shown in Figure 4 and a concerned call from the demo contractor. He asked if it was ok that the column bars were buckling out about 2 inches as they demolished the concrete column. Quickly back-calculating, it was determined that around $\frac{1}{8}$ inch of vertical deflection could cause a 2-inch buckle in a bar over the story height. A $\frac{1}{8}$ -inch vertical deflection was undoubtedly well within expectations of building movement when a column is removed. Fears of collapse were quelled, and demolition proceeded.

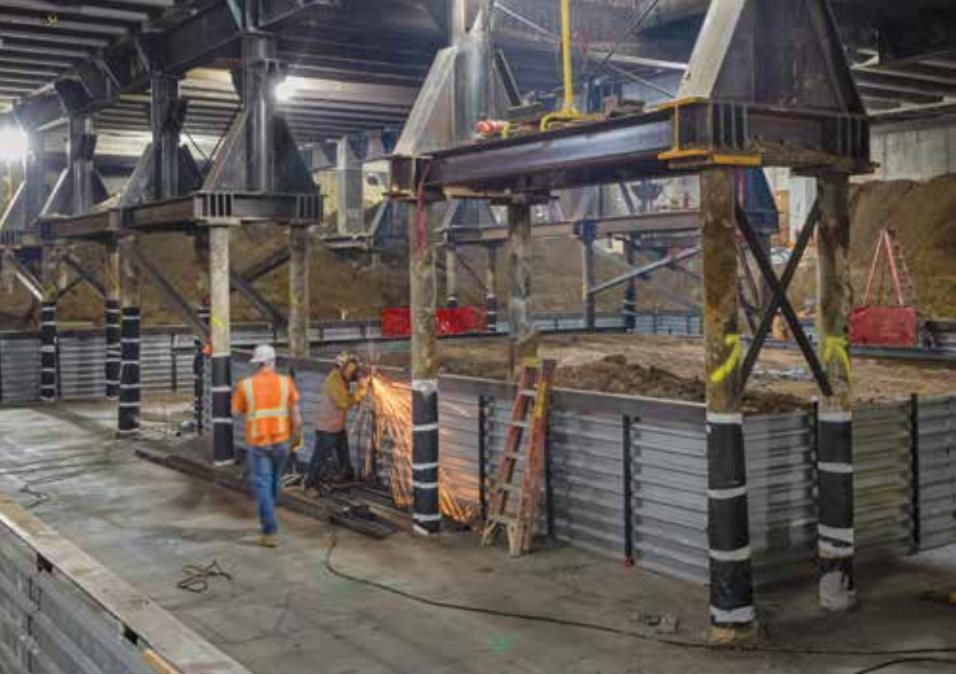
Figure 5. Steel foundation forms installed and building supported on exposed piles.

the new footings exposed around 11 feet of the previously buried cased micropiles (Figure 5). The casing provided buckling resistance to the micropile, which the surrounding soil would typically provide. The shoring carried all 8 million pounds of load at this stage, and the shoring system was in its most vulnerable state.

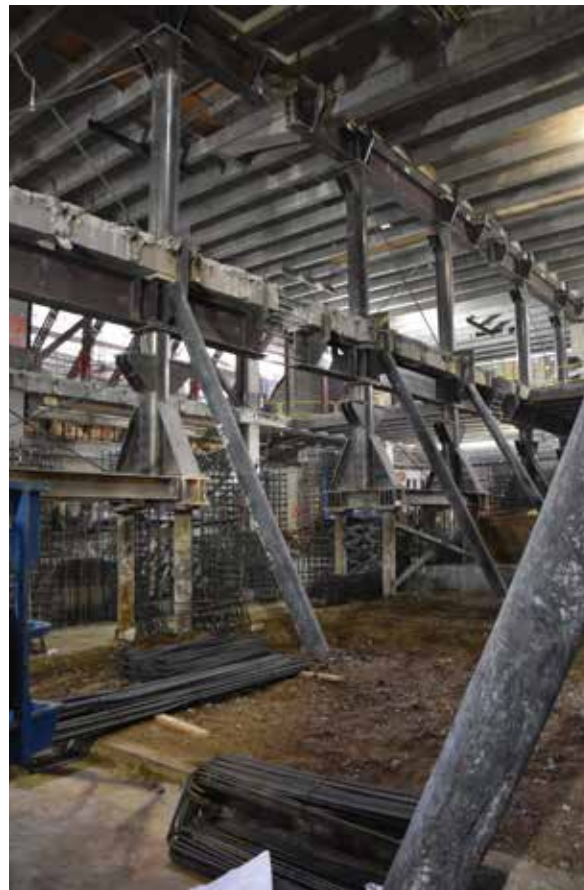
Figure 6. Shoring braced with the first floor demolished.

The column shoring system was still supporting the building, and the shoring stopped and started under and over the first-floor girders. The concrete girders temporarily remained, but the slab and joist of the first floor were demolished. By demolishing the first floor, the shores would buckle without the bracing provided by the floor. A series of steel pipe kickers were anchored to the new building foundations and up to the shoring columns to provide bracing (Figure 6). The American Institute of Steel Construction (AISC) provides requirements for bracing.
