HISTORIC ALAMEDA HIGH SCHOOL RETROFIT

PART 1: TOO VALUABLE TO DEMOLISH, TOO EXPENSIVE TO RETROFIT

By Nik Blanchette, P.E., Steve Heyne, S.E., and Chris Warner, S.E.

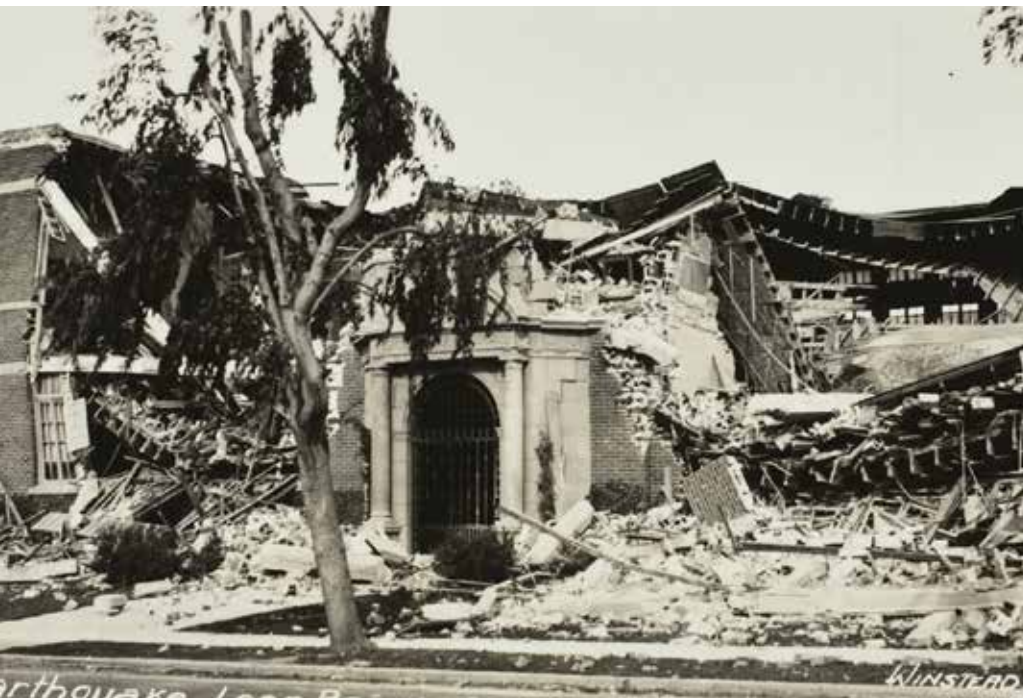
A school destroyed by the 1933 Long Beach earthquake.

In the early evening of March 10, 1933, less than 10 years after the construction of the HAHS campus, a magnitude 6.4 earthquake jolted Long Beach, California. Widespread damage occurred, primarily to unreinforced masonry structures. Among the wreckage were 70 destroyed schools and 120 damaged schools, totaling about 75% of the schools in the Long Beach area. Thankfully, few students and staff were present, though fatalities were not avoided.

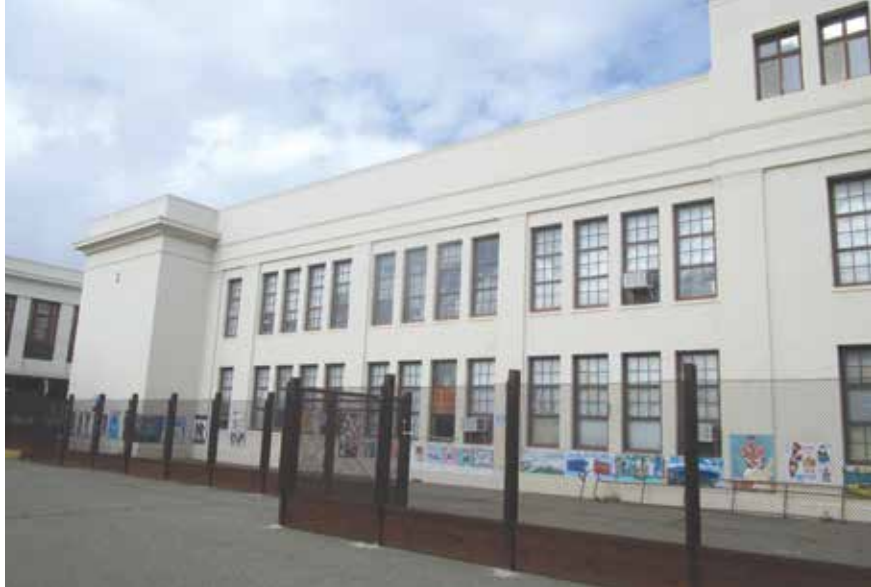
Structural debris fence surrounding an abandoned building.
