## STRUCTURAL UPDATES

Hurricane Katrina

## Bridging the Gaps

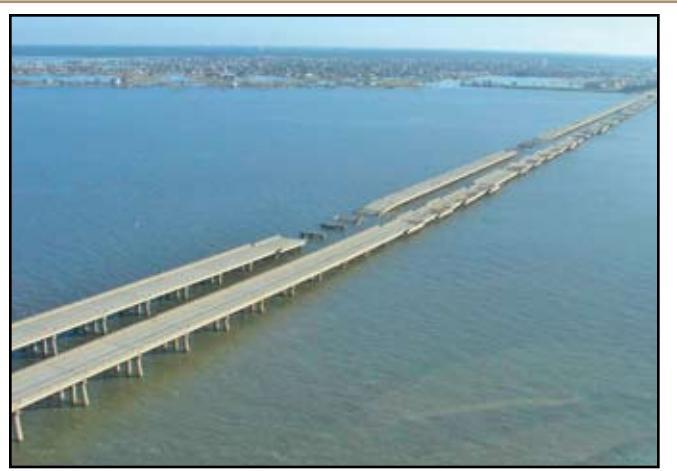
To fully comprehend the damage incurred and the repairs required, one needed to understand the dynamics and sequence of events of how Katrina impacted the Twin Spans bridge. As Katrina moved to the north and east of the site, the storm surge entered Lake Ponchartrain from the east while the wave action came from the north and northwest. Figure 1: Damaged I-10 "Twin Spans" looking north At this location, Twin Spans

runs predominately north-south. With the low members of the bridge at approximately 8.5 feet above mean high water, the storm waters rose to depths that totally encapsulated the 260-ton precast units. As a result, air pockets formed beneath the bridge and buoyed the spans. This phenomenon combined with the wind and wave action to cause a general shift of all spans to the east. The structure experienced repeated damage to the girders, with the failure of nearly all anchor bolts. This left the only lateral restraint to be provided by the elevated bearing seats.

Thirty-eight spans on the eastbound structure fell into the water, while 20 spans on the westbound structure fell. On the eastbound structure, 171 spans were misaligned, while 303 spans were misaligned on the westbound structure. Because of the extensive misalignment, girder damage, and more than three miles of damaged barrier railing on the westbound structure, it was decided that the eastbound structure would be repaired first. To

> The repair process was to cannibalize the good spans from the westbound bridge and move them to the eastbound bridge to yield a complete structure. The remaining spans on the westbound bridge were then arranged to yield two continuous gaps of missing spans — one each on the north and south end of the bridge. In

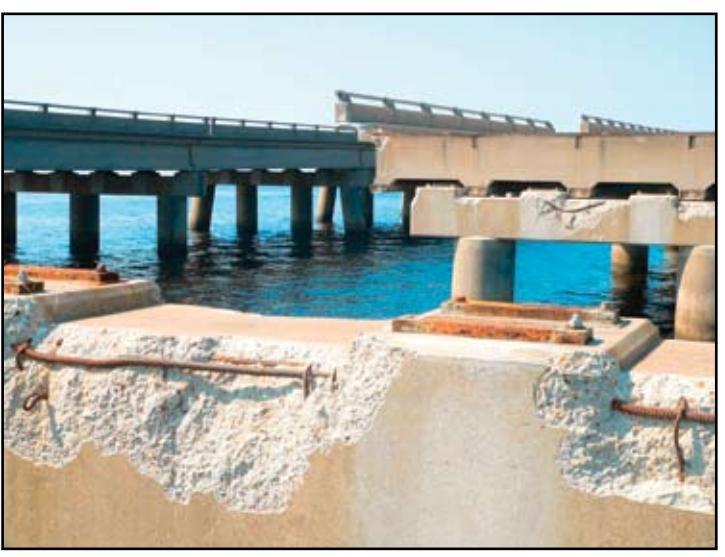
Figure 2: Failed Anchor Bolts and Shifted Spans

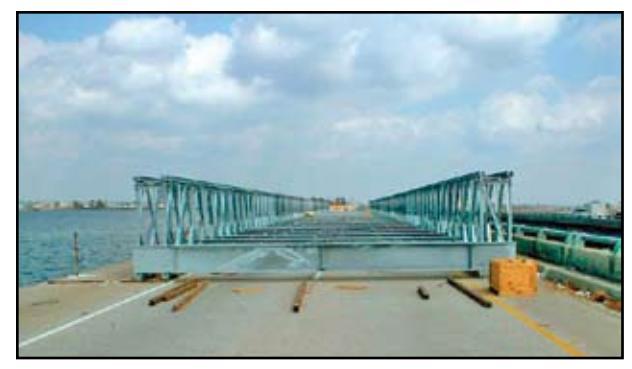
Figure 3: Temporary Acrow Span for the WB Bridge

these locations, temporary steel Acrow trusses (700 series) were installed on the existing bents to bridge the gaps.

The project required a high degree of innovation, collaboration, and trust. The entire process was unconventional in that there was very little time for ordering materials. Resources were scarce due to the damage to nearly all local suppliers. The repairs were varied in nature and included helper bents (needle beams supported on 4-24 inch pipe piles), four new pile bents, re-alignment of 473 of the project's 872 spans, and the use of 506 25-ton screw jacks to support the moderately damaged girders. In addition to these repairs, the project also utilized 320 neoprene bearings, 638 custom-cut bearing plates made of Teflon-like materials to replace the missing bronze bearing plates, 96 saddles to support the more heavily damaged girders, modified 68 bents to accept the Acrow bridge, and epoxy injection of approximately 2,000 feet of cracks.

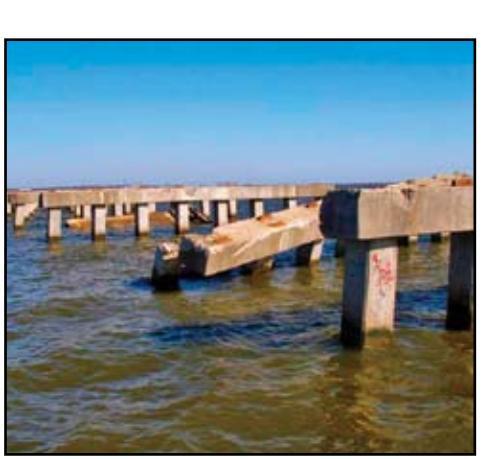
In a similar manner, the U.S. 90 structures in Bay St. Louis and Biloxi, Mississippi experienced extensive damage. The storm surge and resulting wave/wind forces were such that these structures were damaged beyond repair. The replacement structures, as with the Twin Spans Bridge in Louisiana, will be built on new alignments with an increased vertical profile.

Figure 4: Destroyed US 90 Bridge over St. Louis Bay

In case of the Bay St. Louis Bridge, the height of the low member will be 38 feet above mean high water. This structure was recently awarded to the design/build team of Granite/Archer Western with a bid of \$275 million. HNTB Corporation and RS&H are serving as the design engineers. Completion is expected in November 2007. As everyone prepares for a new hurricane season, the continued recovery effort is truly expeditiously bridging the gaps.•
