Guest Column

Creating Redundancy in Building Envelope Design

By Scott Lockyear, P.E.

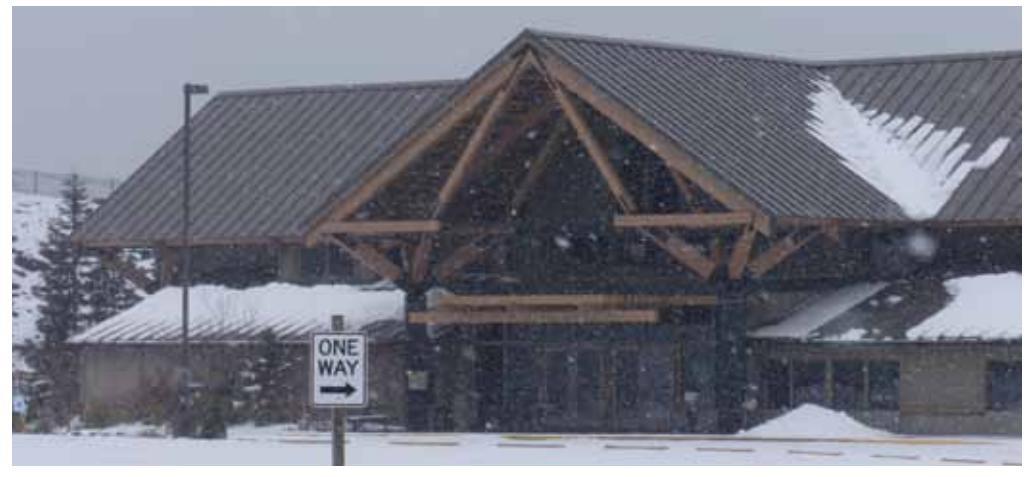
Figure 1: Sloped roof and overhangs protect the building from moisture accumulation.

One common technique is the use of pitched roof systems instead of flat roofs. In commercial construction, it is common for buildings to utilize flat roof systems with parapet walls. While these are ideal for providing partial concealment of roof top units and allow easy access for maintenance, they are also more susceptible to water ponding. Additionally, it is common in low-slope roof construction to omit overhangs, which increases the bulk water absorbed by the wall system. Overhangs and sloped roof systems, as shown in *Figure 1*, are effective tools to divert moisture away from buildings. In 1996, a report was commissioned by the Canadian Mortgage and Housing Corporation to study the impact of overhang length on moisture related wall issues. Results from the study (*Figure 2*) clearly show that, as overhang length decreases, the likelihood of moisture problems in the wall cavity increases. Based on these numbers, a 2-foot overhang may reduce the likelihood of moisture intrusion by over 50 percent in exterior walls. If moisture is diverted from the walls, it also follows that breaches in the building envelope are less of an issue.

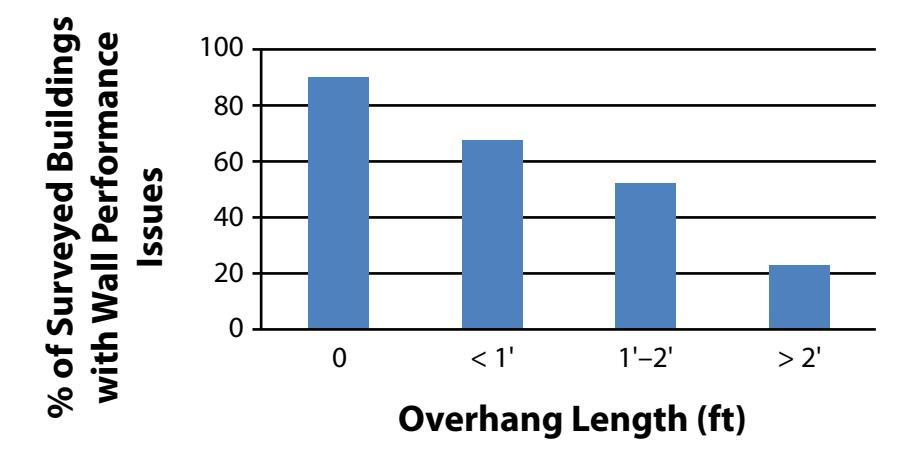
Figure 2: Effect of overhang length on wall performance.

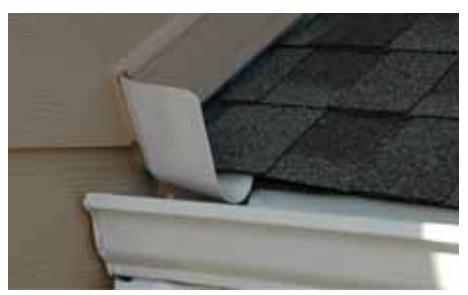
Figure 3: Kickout flashing.

Another key element in diverting moisture away from walls is the use of a properly designed drainage system. One area where proper drainage is commonly overlooked is at the eaves where roofs and walls intersect. As shown in *Figure 3*, kickout flashing has been installed to guide roof runoff into the gutter without saturating wall cladding.

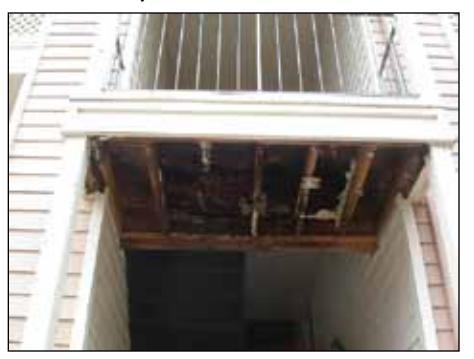
Figure 5: Breezeway with no plastic membrane installed.

Unfortunately, failures in membrane design and installations do occur, which creates a potential need for redundancy in the envelope design. Use of preservative treated wood components can provide this redundancy in exterior balconies. The concept of redundancy can also be used on breezeways where concrete toppings may act as a sponge for moisture. Figure 5 is an extreme case, given that the protective membrane was completely omitted leading to premature failure. While the use of preservative treated wood will not prevent rusting of metal connectors and mold growth, it will protect structural members of the breezeway until the building envelope breach can be identified and repaired. Given the inherent

risk of membrane failures, the situation in *Figure 5* could have occurred even with the membrane in place.

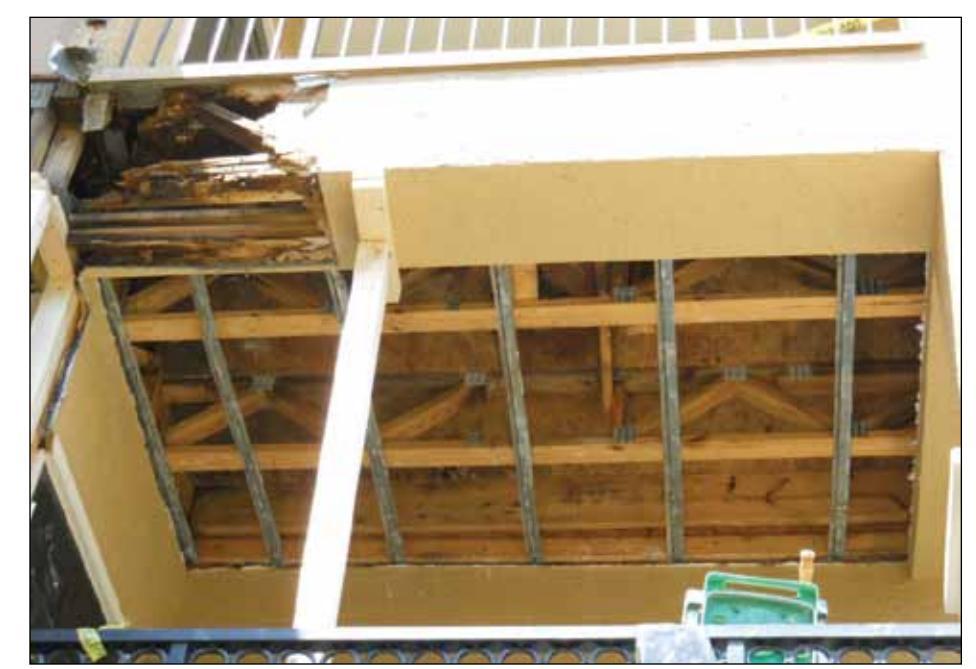
Figure 4: Decay at balcony edge where inadequate drainage provided led to decay.

Puncturing of membranes may occur when balcony handrails and posts or other items are improperly connected over lightweight concrete. Moisture may also circumvent the membrane protection entirely when proper detailing is not provided. This includes prematurely ending the membrane protection at the top of the deck edge, which leads to moisture exposure of the perimeter framing. When this occurs with untreated wood, decay as shown in *Figure 4* is likely.

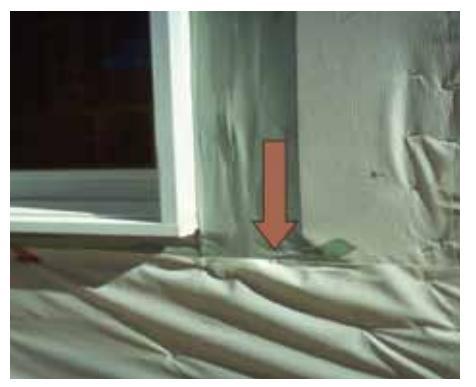
Figure 6: Reverse flashing at window.

Penetrations in the building envelope may result from windows, plumbing, or other systems critical to overall building performance. Proper design and installation techniques can be found in ASTM E2112–07 *Standard Practice for Installation of Exterior Windows, Doors and Skylights.* During installation, it is critical that common mistakes are avoided such as reverse flashing as shown in *Figure 6.*

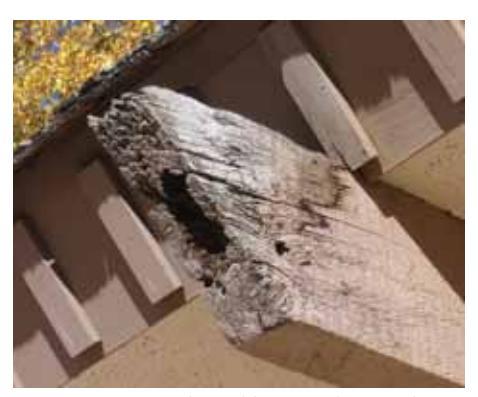
Figure 7: Untreated wood beam with exposed end grain.

One application where untreated wood is often used is rafter overhangs. When detailed properly, an untreated wood overhang may withstand many seasons of rain and snow. However, of particular concern is exposure of wood end grain to moisture. Trees inherently allow easy moisture transport along the grain. In a living tree, water absorbs through its roots and travels up the tree trunk to the limbs and leaves. When trees are cut into timbers, this same mechanism exists, allowing end grain to be more susceptible to uptake of moisture in exterior applications. When designing wood rafters, it is desirable to seal the end grain and situate the beams within the roof system to minimize exposure to wind-driven rain and draining water. When this does not occur, decay may result as shown in Figure 7. Exposed untreated wood may be utilized, provided it does not exceed moisture content of between 16 and 19 percent. Fortunately, wood in unexposed applications will have moisture content much lower than this unless a building envelope design failure occurs.
